Access Compliance Report

Public Rights-of-Way

(Curb Ramps)

Intersection ID: N/A	Main Street: E MARTIN LUTHER KING JR BLVD	Cross Street: S CALDWELL ST	Location: SE
ADA ID: CF9FA9BAEF08	Ramp Type: Perp	Initial Pass/Fail: Pass	Overall Compliance: No
Severity Score: 0			
Codes/Mitigation Info/Possible Solution		Field Measurements/Component Compliance

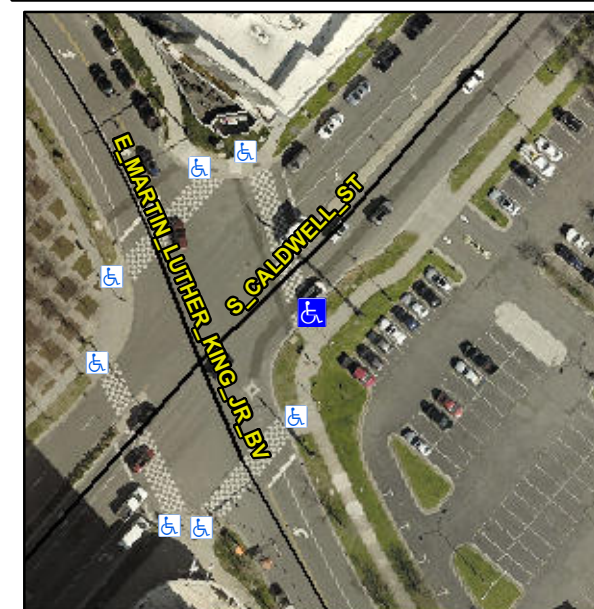
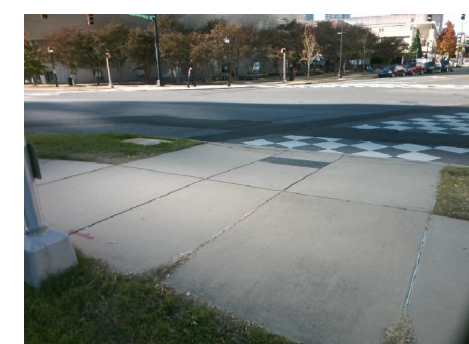
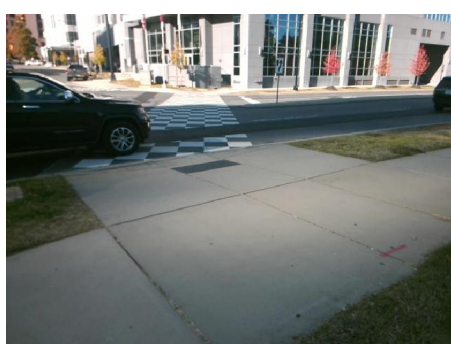
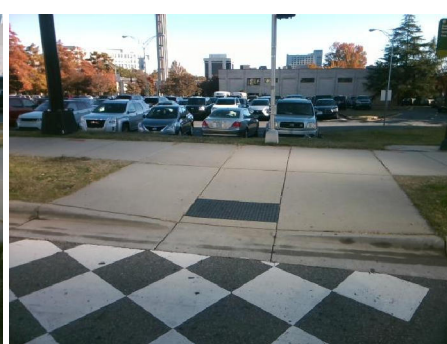
Compliance	Description	Data	Compliance	Description	Data
N/A	Ramp Length (in)	95.0	Yes	Ramp Slope (%)	6.7
Yes	Ramp Width (in)	48.5	Yes	Ramp XSlope (%)	1.1
N/A	Flare Type LT	Sloped	N/A	Flare Type RT	N/A
N/A	Flare Slope LT (%)	6.3	N/A	Flare Slope RT (%)	5.4
N/A	Flare Traversable LT?	No	N/A	Flare Traversable RT?	No
Yes	Landing Length (in)	97.0	Yes	DWS Provided?	Yes
Yes	Landing Width (in)	50.0	Yes	DWS Contrast?	Yes
Yes	Landing Slope (%)	1.7	Yes	DWS Length (in)	24.5
Yes	Landing X Slope (%)	0.6	Yes	DWS Full Width?	Yes
N/A	Landing Curb? (Y/N)	No	No	DWS Offset (in)	7.5
N/A	Shared Landing?	No			
Yes	Gutter Ponding?	No	Yes	Gutter Slope (%)	0.7
Yes	Gutter Lip Ht (in)	0.0	Yes	Gutter X Slope (%)	0.2
N/A	Painted X Walk1?	Yes	N/A	Painted X Walk2?	N/A
	X Walk 1 Direction	To N		X Walk 2 Direction	N/A
N/A	X Walk 1 Width (in)	144.0	N/A	X Walk 2 Width (in)	N/A
	X Walk 1 Slope (%)	1.3		X Walk 2 Slope (%)	N/A
	X Walk 1 X Slope (%)	0.7		X Walk 2 X Slope (%)	N/A

Yes	Ramp inside XWalk1?	Yes	N/A	Ramp inside XWalk2?	N/A
	Road Slope (%)	N/A	N/A	Clear Space?	Yes
	Road X Slope (%)	N/A	N/A	Clear Space to XWalk (in)	N/A
Yes	Any Obstructions?	No	Yes	Storm Grate/Utility Hazard?	No
	Obstruction Type			Storm Grate/Utility Type	
		N/A			N/A
			Yes	Surface Condition? (G/P)	Good

Possible Solutions:

Remove & Replace Detectable Warning System.

R305.2

\$ 800.00
