# Access Compliance Report

## Public Rights-of-Way

### (Curb Ramps)

Intersection ID: 28069	Main Street: PROVIDENCE_RD_WEST	Cross Street: WYNDHAM_OAKS_DR	Location: NE
ADA ID: CFA33E8B7FC3	Ramp Type: PerpDiag	Initial Pass/Fail: Fail	Overall Compliance: No
Severity Score: 12.5			
Codes/Mitigation Info/Possible Solution		Field Measurements/Component Compliance

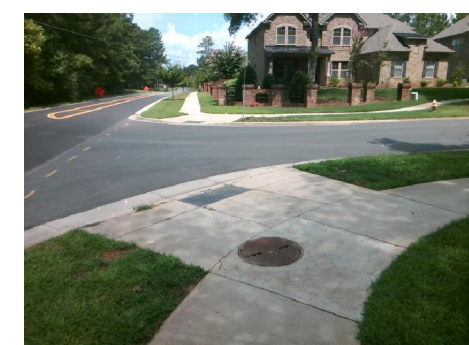
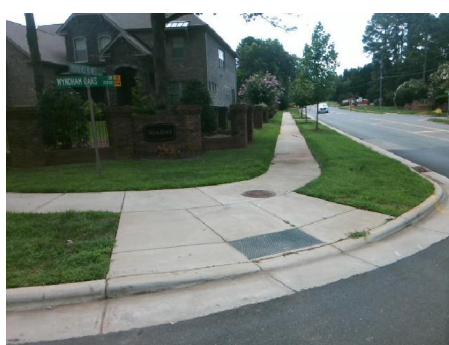
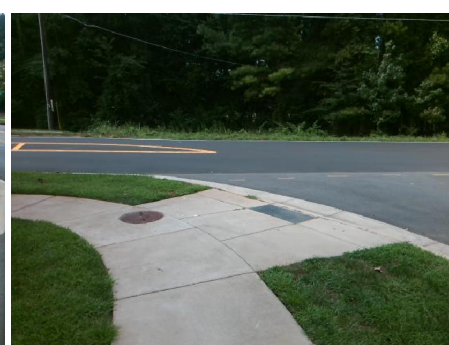
**Not Found, R304.5.3**

Compliance	Description	Data	Compliance	Description	Data
N/A	Ramp Length (in)	88.0	Yes	Ramp Slope (%)	7.0
Yes	Ramp Width (in)	48.0	No	Ramp XSlope (%)	5.8
N/A	Flare Type LT	N/A	N/A	Flare Type RT	N/A
N/A	Flare Slope LT (%)	N/A	N/A	Flare Slope RT (%)	N/A
N/A	Flare Traversable LT?	N/A	N/A	Flare Traversable RT?	N/A
N/A	Landing Length (in)	N/A	N/A	DWS Provided?	N/A
N/A	Landing Width (in)	N/A	N/A	DWS Contrast?	N/A
N/A	Landing Slope (%)	N/A	N/A	DWS Length (in)	N/A
N/A	Landing X Slope (%)	N/A	N/A	DWS Full Width?	N/A
N/A	Landing Curb? (Y/N)	N/A	N/A	DWS Offset (in)	N/A
N/A	Shared Landing?	N/A			
N/A	Gutter Ponding?	N/A	N/A	Gutter Slope (%)	N/A
N/A	Gutter Lip Ht (in)	N/A	N/A	Gutter X Slope (%)	N/A
N/A	Painted X Walk1?	No	N/A	Painted X Walk2?	No
	X Walk 1 Direction	To NW		X Walk 2 Direction	To SW
N/A	X Walk 1 Width (in)	N/A	N/A	X Walk 2 Width (in)	N/A
	X Walk 1 Slope (%)	2.9		X Walk 2 Slope (%)	1.3
	X Walk 1 X Slope (%)	0.9		X Walk 2 X Slope (%)	2.9

N/A	Ramp inside XWalk1?	N/A	N/A	Ramp inside XWalk2?	N/A
	Road Slope (%)	1.0	N/A	Clear Space?	N/A
	Road X Slope (%)	1.4	N/A	Clear Space to XWalk (in)	N/A
N/A	Any Obstructions?	N/A	N/A	Storm Grate/Utility Hazard?	N/A
	Obstruction Type			Storm Grate/Utility Type	
		N/A			N/A
			Yes	Surface Condition? (G/P)	Good

**Remove & Replace Curb Ramp With Two New Directional Ramps or Equivalent.**
