## Access Compliance Report Public Rights-of-Way (Curb Ramps)

Intersection ID: 23966Main Street:CAROLINA\_PAVILION\_DR\_NCross Street:SOUTH\_BVLocation:NEADA ID: CFAE25F20B4FRamp Type:PerpInitial Pass/Fail:FailOverall Compliance:NoSeverity Score:25

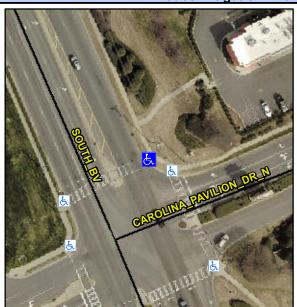
Comp	liance Description	Data	Comp	oliance Description	Data
N/A	Ramp Length (in)	63.0	No	Ramp Slope (%)	13.9
Yes	Ramp Width (in)	48.0	Yes	Ramp XSlope (%)	0.2
N/A	Flare Type LT	N/A	N/A	Flare Type RT	N/A
N/A	Flare Slope LT (%)	N/A	N/A	Flare Slope RT (%)	N/A
N/A	Flare Traversable LT?	N/A	N/A	Flare Traversable RT?	N/A
N/A	Landing Length (in)	N/A	N/A	DWS Provided?	N/A
N/A	Landing Width (in)	N/A	N/A	DWS Contrast?	N/A
N/A	Landing Slope (%)	N/A	N/A	DWS Length (in)	N/A
N/A	Landing X Slope (%)	N/A	N/A	DWS Full Width?	N/A
N/A	Landing Curb? (Y/N)	N/A	N/A	DWS Offset (in)	N/A
N/A	Shared Landing?	N/A			
N/A	Gutter Ponding?	N/A	N/A	Gutter Slope (%)	N/A
N/A	Gutter Lip Ht (in)	N/A	N/A	Gutter X Slope (%)	N/A
N/A	Painted X Walk1?	Yes	N/A	Painted X Walk2?	N/A
	X Walk 1 Direction	To W		X Walk 2 Direction	N/A
N/A	X Walk 1 Width (in)	110.0	N/A	X Walk 2 Width (in)	N/A
	X Walk 1 Slope (%)	1.1		X Walk 2 Slope (%)	N/A
	X Walk 1 X Slope (%)	0.1		X Walk 2 X Slope (%)	N/A

N/A	Ramp inside XWalk1?	Yes	N/A	Ramp inside XWalk2?	N/A
	Road Slope (%)	N/A	N/A	Clear Space?	N/A
	Road X Slope (%)	N/A	N/A	Clear Space to XWalk (in)	N/A
N/A	Any Obstructions?	N/A	N/A	Storm Grate/Utility Hazard?	N/A
	Obstruction Type		l	Storm Grate/Utility Type	
		N/A			N/A
			Yes	Surface Condition? (G/P)	Good
1	4

Possible Solutions:	Co
Remove & Replace Entire Ramp.	N/A
·	Yes
	N/A
	N/A
	N/A
	N/A
Surveyor Notes:	N/A
N/A	N/A
	N/A
	N/A
	N/A
PROW/ADA:	N/A
Not Found, R304.2.2	N/A
	N/A
	N/A
	N/A
