Access Compliance Report

Public Rights-of-Way

(Curb Ramps)

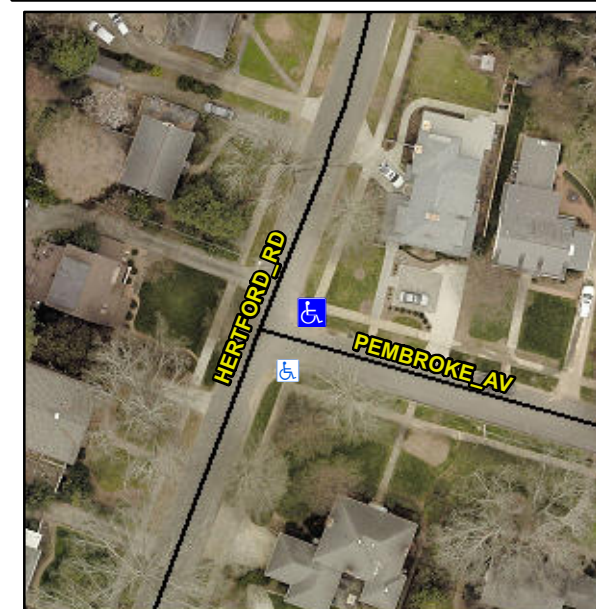
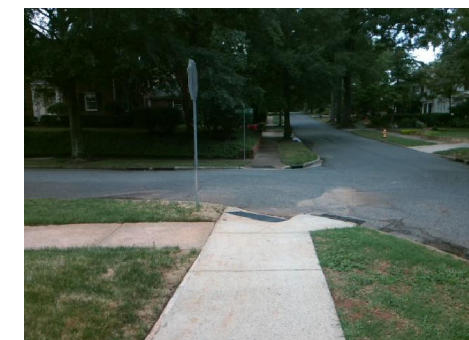
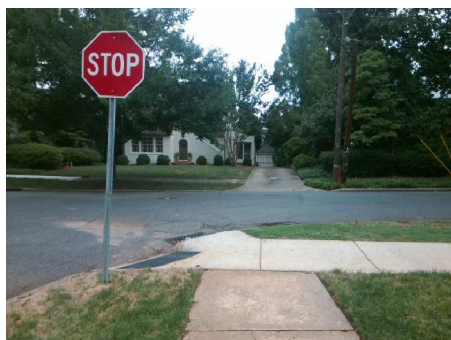
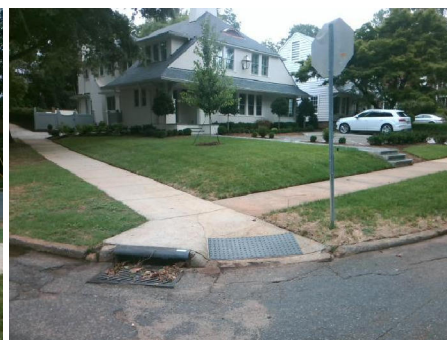
Intersection ID: 15889	Main Street: HERTFORD_RD	Cross Street: PEMBROKE_AV	Location: NE
ADA ID: CFB03758B5C1	Ramp Type: Directional1	Initial Pass/Fail: Fail	Overall Compliance: No
Severity Score: 58.75			
Codes/Mitigation Info/Possible Solution		Field Measurements/Component Compliance

R304.5.1, R304.2.2, R304.5.3

Compliance	Description	Data	Compliance	Description	Data
N/A	Ramp Length (in)	42.0	N/A	Grade Break?	N/A
No	Ramp Width (in)	42.0	N/A	Grade Break Slope (%)	0.0
No	Ramp Slope (%)	15.6	N/A	Grade Break XSlope (%)	0.0
No	Ramp XSlope (%)	9.1			
N/A	Flare Type LT	N/A	N/A	Flare Type RT	N/A
N/A	Flare Slope LT (%)	N/A	N/A	Flare Slope RT (%)	0.0
N/A	Flare Traversable LT?	N/A	N/A	Flare Traversable RT?	N/A
N/A	Landing Length (in)	0.0	N/A	DWS Provided?	N/A
N/A	Landing Width (in)	0.0	N/A	DWS Contrast?	N/A
N/A	Landing Slope (%)	0.0	N/A	DWS Length (in)	N/A
N/A	Landing X Slope (%)	0.0	N/A	DWS Full Width?	N/A
N/A	Landing Curb? (Y/N)	N/A	N/A	DWS Offset LT (in)	N/A
N/A	Shared Landing?	N/A	N/A	DWS Offset RT (in)	N/A
N/A	Gutter Ponding?	0.0	N/A	Gutter Slope (%)	N/A
N/A	Gutter Lip Ht (in)	0.0	N/A	Gutter X Slope (%)	N/A
N/A	Painted X Walk1?	No		Road Slope (%)	3.0
	X Walk 1 Direction	To S		Road X Slope (%)	0.3
	X Walk 1 Width (in)	N/A		Clear Space?	N/A

X Walk 1 Slope (%)	3.0	N/A	Clear Space to XWalk (in)	N/A
	X Walk 1 X Slope (%)	0.3	N/A	Storm Grate/Utility Hazard?	N/A
N/A	Ramp inside XWalk1?	N/A		Storm Grate/Utility Type	
N/A	Any Obstructions?	N/A			N/A
	Obstruction Type		Yes	Surface Condition? (G/P)	Good
			N/A	Curb Slope (%)	12.5

Possible Solutions:

Remove & Replace Entire Ramp.
