# Access Compliance Report

## Public Rights-of-Way

### (Curb Ramps)

Intersection ID: 14857	Main Street: ATHERTON_ST	Cross Street: SOUTH_BV	Location: S
ADA ID: CFB2C55DD619	Ramp Type: Perp	Initial Pass/Fail: Fail	Overall Compliance: No
Severity Score: 10			
Codes/Mitigation Info/Possible Solution		Field Measurements/Component Compliance

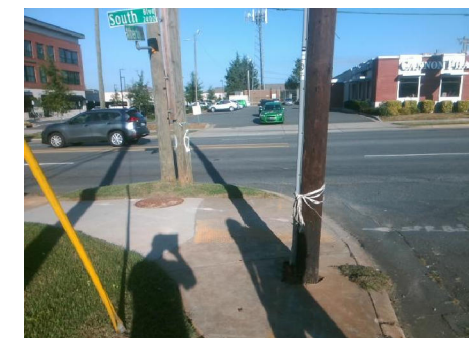
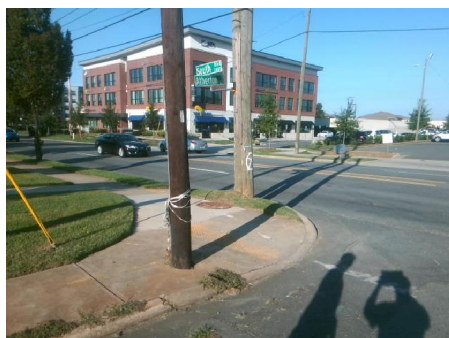
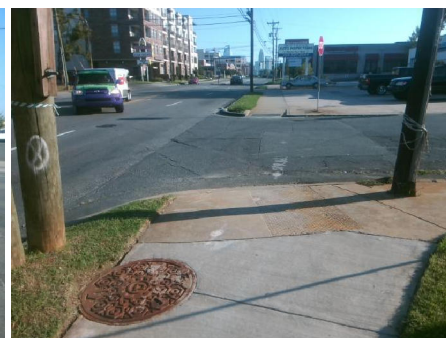
Compliance	Description	Data	Compliance	Description	Data
N/A	Ramp Length (in)	77.0	Yes	Ramp Slope (%)	6.5
No	Ramp Width (in)	37.0	No	Ramp XSlope (%)	2.5
N/A	Flare Type LT	N/A	N/A	Flare Type RT	N/A
N/A	Flare Slope LT (%)	N/A	N/A	Flare Slope RT (%)	N/A
N/A	Flare Traversable LT?	N/A	N/A	Flare Traversable RT?	N/A
N/A	Landing Length (in)	N/A	N/A	DWS Provided?	N/A
N/A	Landing Width (in)	N/A	N/A	DWS Contrast?	N/A
N/A	Landing Slope (%)	N/A	N/A	DWS Length (in)	N/A
N/A	Landing X Slope (%)	N/A	N/A	DWS Full Width?	N/A
N/A	Landing Curb? (Y/N)	N/A	N/A	DWS Offset (in)	N/A
N/A	Shared Landing?	N/A			
N/A	Gutter Ponding?	N/A	N/A	Gutter Slope (%)	N/A
N/A	Gutter Lip Ht (in)	N/A	N/A	Gutter X Slope (%)	N/A
N/A	Painted X Walk1?	No	N/A	Painted X Walk2?	N/A
	X Walk 1 Direction	To NE		X Walk 2 Direction	N/A
N/A	X Walk 1 Width (in)	N/A	N/A	X Walk 2 Width (in)	N/A
	X Walk 1 Slope (%)	6.5		X Walk 2 Slope (%)	N/A
	X Walk 1 X Slope (%)	3.6		X Walk 2 X Slope (%)	N/A

N/A	Ramp inside XWalk1?	N/A	N/A	Ramp inside XWalk2?	N/A
	Road Slope (%)	N/A	N/A	Clear Space?	N/A
	Road X Slope (%)	N/A	N/A	Clear Space to XWalk (in)	N/A
N/A	Any Obstructions?	N/A	N/A	Storm Grate/Utility Hazard?	N/A
	Obstruction Type			Storm Grate/Utility Type	
		N/A			N/A
			Yes	Surface Condition? (G/P)	Good

**Remove & Replace Entire Ramp.**
