# Access Compliance Report

## Public Rights-of-Way

### (Curb Ramps)

Intersection ID: 47911	Main Street: ROOK_RD	Cross Street: RINGNECK_RD	Location: SW
ADA ID: CFBDBBE547D2	Ramp Type: PerpDiag	Initial Pass/Fail: Pass	Overall Compliance: No
Severity Score: 5.25			
Codes/Mitigation Info/Possible Solution		Field Measurements/Component Compliance

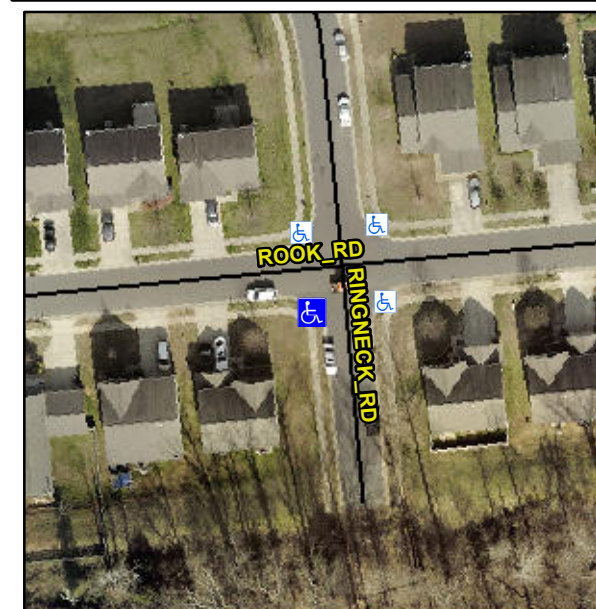
Compliance	Description	Data	Compliance	Description	Data
N/A	Ramp Length (in)	47.0	Yes	Ramp Slope (%)	6.7
Yes	Ramp Width (in)	48.0	No	Ramp XSlope (%)	4.1
N/A	Flare Type LT	Sloped	N/A	Flare Type RT	N/A
N/A	Flare Slope LT (%)	5.2	Yes	Flare Slope RT (%)	0.5
N/A	Flare Traversable LT?	Yes	N/A	Flare Traversable RT?	Yes
Yes	Landing Length (in)	48.0	Yes	DWS Provided?	Yes
Yes	Landing Width (in)	48.0	Yes	DWS Contrast?	Yes
Yes	Landing Slope (%)	1.1	Yes	DWS Length (in)	24.0
No	Landing X Slope (%)	5.2	Yes	DWS Full Width?	Yes
N/A	Landing Curb? (Y/N)	No	No	DWS Offset (in)	3.5
N/A	Shared Landing?	No			
Yes	Gutter Ponding?	No	No	Gutter Slope (%)	6.2
Yes	Gutter Lip Ht (in)	0.0	No	Gutter X Slope (%)	2.8
N/A	Painted X Walk1?	No	N/A	Painted X Walk2?	No
	X Walk 1 Direction	To E		X Walk 2 Direction	To N
N/A	X Walk 1 Width (in)	N/A	N/A	X Walk 2 Width (in)	N/A
	X Walk 1 Slope (%)	2.9		X Walk 2 Slope (%)	1.8
	X Walk 1 X Slope (%)	2.8		X Walk 2 X Slope (%)	2.3

N/A	Ramp inside XWalk1?	N/A	N/A	Ramp inside XWalk2?	N/A
	Road Slope (%)	3.8	N/A	Clear Space?	Yes
	Road X Slope (%)	0.5	N/A	Clear Space to XWalk (in)	N/A
Yes	Any Obstructions?	No	Yes	Storm Grate/Utility Hazard?	No
	Obstruction Type			Storm Grate/Utility Type	
		N/A			N/A
		Yes		Surface Condition? (G/P)	Good

**Remove & Replace Curb Ramp With Two New Directional Ramps or Equivalent. Remove & Replace Gutter.**

**R304.5.3, R305.2, R304.5.4**

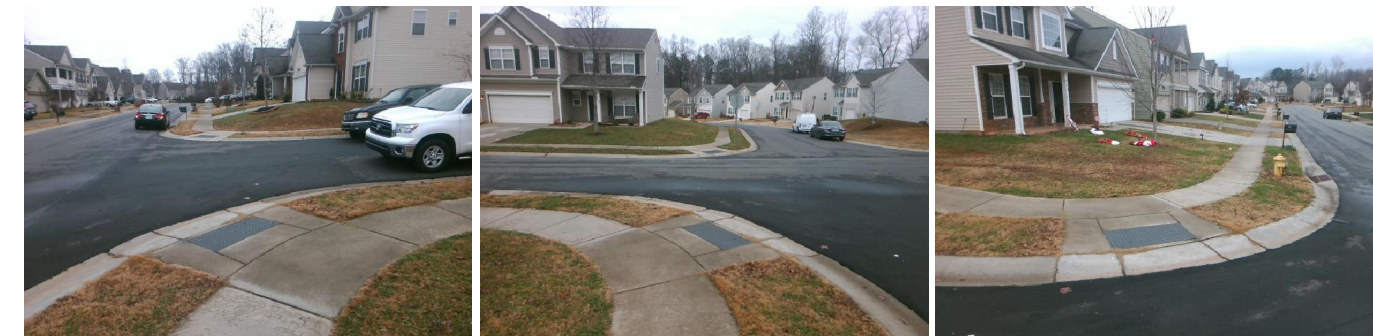
Street 1 Name RINGNECK RD  
 Stop Condition-Street 2 StopSign  
 Street 2 Name ROOK RD  
 Stop Condition-Street 1 None

Possible Solutions:

Total Cost: \$ 3950.00
