Access Compliance Report

Public Rights-of-Way

(Curb Ramps)

Intersection ID: N/A	Main Street: KIRKWYND COMMONS DR	Cross Street: BRECKFIELD CT	Location: NW
ADA ID: CFC3A354F0D0	Ramp Type: PerpDiag	Initial Pass/Fail: Fail	Overall Compliance: No
Severity Score: 13.75			
Codes/Mitigation Info/Possible Solution		Field Measurements/Component Compliance

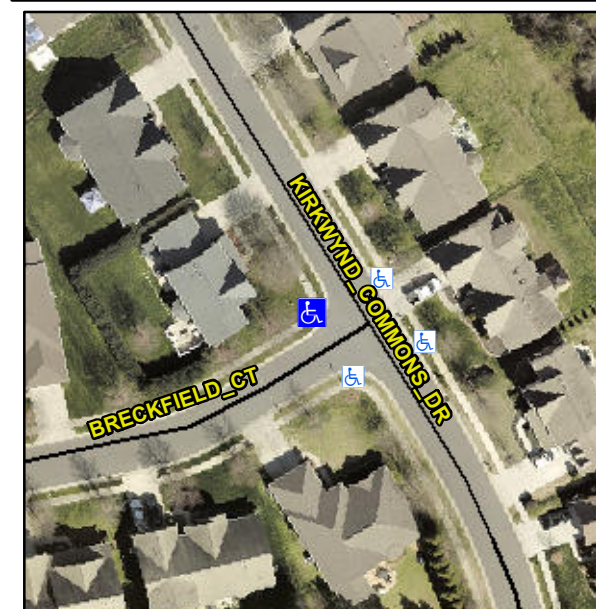
R304.2.2, R304.5.3

Compliance	Description	Data	Compliance	Description	Data
N/A	Ramp Length (in)	48.0	No	Ramp Slope (%)	8.9
Yes	Ramp Width (in)	48.0	No	Ramp XSlope (%)	4.5
N/A	Flare Type LT	N/A	N/A	Flare Type RT	N/A
N/A	Flare Slope LT (%)	N/A	N/A	Flare Slope RT (%)	N/A
N/A	Flare Traversable LT?	N/A	N/A	Flare Traversable RT?	N/A
N/A	Landing Length (in)	N/A	N/A	DWS Provided?	N/A
N/A	Landing Width (in)	N/A	N/A	DWS Contrast?	N/A
N/A	Landing Slope (%)	N/A	N/A	DWS Length (in)	N/A
N/A	Landing X Slope (%)	N/A	N/A	DWS Full Width?	N/A
N/A	Landing Curb? (Y/N)	N/A	N/A	DWS Offset (in)	N/A
N/A	Shared Landing?	N/A			
N/A	Gutter Ponding?	N/A	N/A	Gutter Slope (%)	N/A
N/A	Gutter Lip Ht (in)	N/A	N/A	Gutter X Slope (%)	N/A
N/A	Painted X Walk1?	No	N/A	Painted X Walk2?	No
	X Walk 1 Direction	To SE		X Walk 2 Direction	To NE
N/A	X Walk 1 Width (in)	N/A	N/A	X Walk 2 Width (in)	N/A
	X Walk 1 Slope (%)	3.8		X Walk 2 Slope (%)	0.8
	X Walk 1 X Slope (%)	1.5		X Walk 2 X Slope (%)	1.9

N/A	Ramp inside XWalk1?	N/A	N/A	Ramp inside XWalk2?	N/A
	Road Slope (%)	3.1	N/A	Clear Space?	N/A
	Road X Slope (%)	0.8	N/A	Clear Space to XWalk (in)	N/A
N/A	Any Obstructions?	N/A	N/A	Storm Grate/Utility Hazard?	N/A
	Obstruction Type			Storm Grate/Utility Type	
		N/A			N/A
			Yes	Surface Condition? (G/P)	Good

Remove & Replace Curb Ramp With Two New Directional Ramps or Equivalent.
