Access Compliance Report

Public Rights-of-Way

(Curb Ramps)

Intersection ID: 6044	Main Street: GRENELEFE_VILLAGE_RD	Cross Street: HOSTA_DR	Location:	N
ADA ID: CFC78AD5ECA0	Ramp Type: Perp	Initial Pass/Fail: Fail	Overall Compliance: No	Severity Score: 26.25
Codes/Mitigation Info/Possible Solution		Field Measurements/Component Compliance

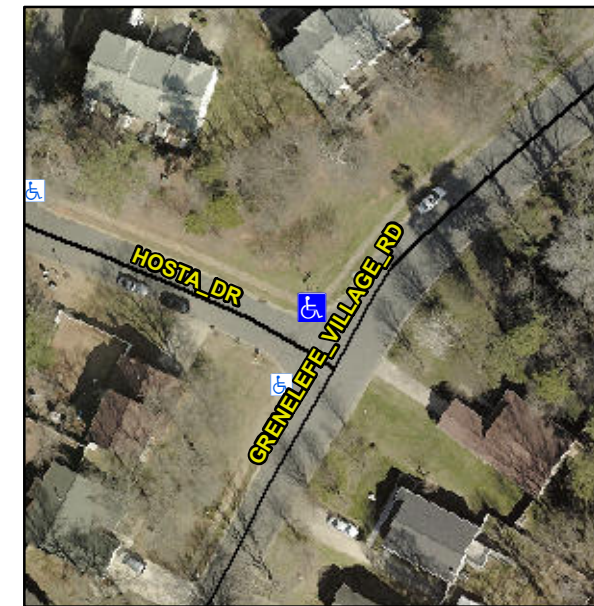
Not Found, R304.2.2, R304.5.3

Compliance	Description	Data	Compliance	Description	Data
N/A	Ramp Length (in)	47.0	No	Ramp Slope (%)	12.5
Yes	Ramp Width (in)	58.0	No	Ramp XSlope (%)	3.8
N/A	Flare Type LT	N/A	N/A	Flare Type RT	N/A
N/A	Flare Slope LT (%)	N/A	N/A	Flare Slope RT (%)	N/A
N/A	Flare Traversable LT?	N/A	N/A	Flare Traversable RT?	N/A
N/A	Landing Length (in)	N/A	N/A	DWS Provided?	N/A
N/A	Landing Width (in)	N/A	N/A	DWS Contrast?	N/A
N/A	Landing Slope (%)	N/A	N/A	DWS Length (in)	N/A
N/A	Landing X Slope (%)	N/A	N/A	DWS Full Width?	N/A
N/A	Landing Curb? (Y/N)	N/A	N/A	DWS Offset (in)	N/A
N/A	Shared Landing?	N/A			
N/A	Gutter Ponding?	N/A	N/A	Gutter Slope (%)	N/A
N/A	Gutter Lip Ht (in)	N/A	N/A	Gutter X Slope (%)	N/A
N/A	Painted X Walk1?	No	N/A	Painted X Walk2?	N/A
	X Walk 1 Direction	To SW		X Walk 2 Direction	N/A
N/A	X Walk 1 Width (in)	N/A	N/A	X Walk 2 Width (in)	N/A
	X Walk 1 Slope (%)	5.8		X Walk 2 Slope (%)	N/A
	X Walk 1 X Slope (%)	1.2		X Walk 2 X Slope (%)	N/A

N/A	Ramp inside XWalk1?	N/A	N/A	Ramp inside XWalk2?	N/A
	Road Slope (%)	N/A	N/A	Clear Space?	N/A
	Road X Slope (%)	N/A	N/A	Clear Space to XWalk (in)	N/A
N/A	Any Obstructions?	N/A	N/A	Storm Grate/Utility Hazard?	N/A
	Obstruction Type			Storm Grate/Utility Type	
		N/A			N/A
			Yes	Surface Condition? (G/P)	Good

Possible Solutions:

Remove & Replace Entire Ramp.

Total Cost: \$ 1850.00
