# Access Compliance Report

## Public Rights-of-Way

| Intersection ID: 43513 | Main Street: BLACKBERRY RIDGE LN | Cross Street: MULBERRY POND DR | Location: E |
| ADA ID: CFCCF4C2806D | Ramp Type: PerpDiag | Initial Pass/Fail: Fail | Overall Compliance: No |

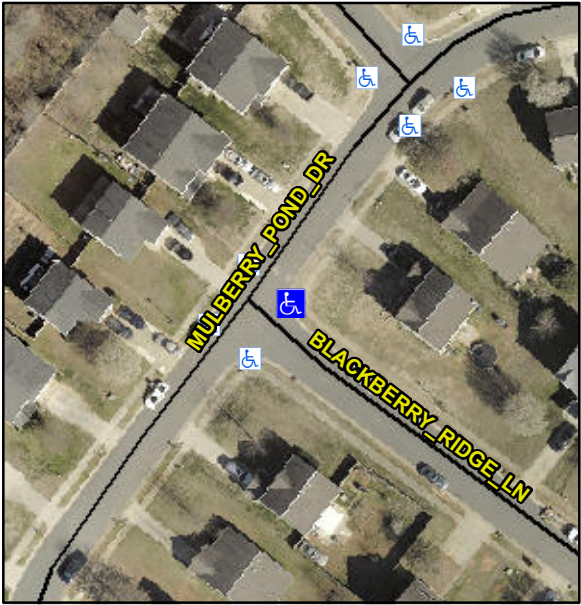
| Codes/Mitigation Info/Possible Solution | | Field Measurements/Component Compliance | | | |
|--|--|---|---|--|--|
| | R304.5.1, R304.5.3 | | | | |

| Compliance | Description | Data | Compliance | Description | Data |
|---|---|---|---|---|---|
| N/A | Ramp Length (in) | 50.0 | Yes | Ramp Slope (%) | 6.5 |
| No | Ramp Width (in) | 31.0 | No | Ramp XSlope (%) | 2.8 |

| Codes/Mitigation Info/Possible Solution | | Field Measurements/Component Compliance | | | |
|--|--|---|---|--|--|
| | Remove & Replace Curb Ramp With Two New Directional Ramps or Equivalent. | | | | |
| Total Cost: | | \$ | 3200.00 | | |
