Access Compliance Report

Public Rights-of-Way

(Curb Ramps)

Intersection ID: 10036062	Main Street: RIVERGATE_PY	Cross Street: N/A	Location: S
ADA ID: CFD962B10211	Ramp Type: PerpDiag	Initial Pass/Fail: Fail	Overall Compliance: No
		Severity Score: 12.5

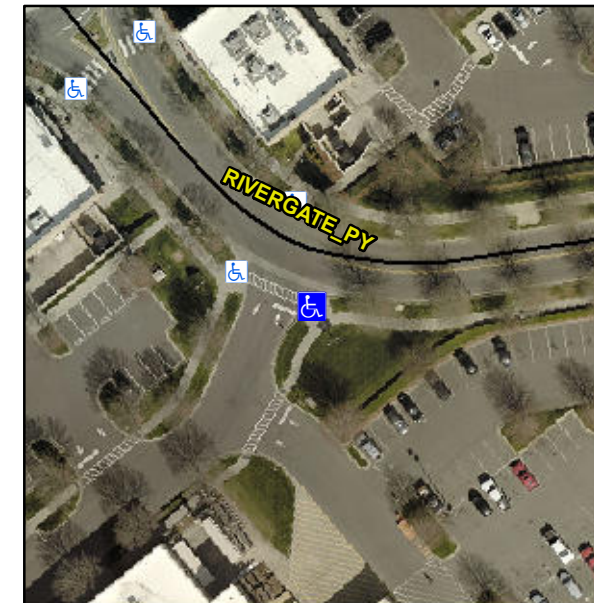
Not Found, R304.5.3

Compliance	Description	Data	Compliance	Description	Data
N/A	Ramp Length (in)	95.0	Yes	Ramp Slope (%)	5.9
Yes	Ramp Width (in)	54.0	No	Ramp XSlope (%)	6.5
N/A	Flare Type LT	N/A	N/A	Flare Type RT	N/A
N/A	Flare Slope LT (%)	N/A	N/A	Flare Slope RT (%)	N/A
N/A	Flare Traversable LT?	N/A	N/A	Flare Traversable RT?	N/A
N/A	Landing Length (in)	N/A	N/A	DWS Provided?	N/A
N/A	Landing Width (in)	N/A	N/A	DWS Contrast?	N/A
N/A	Landing Slope (%)	N/A	N/A	DWS Length (in)	N/A
N/A	Landing X Slope (%)	N/A	N/A	DWS Full Width?	N/A
N/A	Landing Curb? (Y/N)	N/A	N/A	DWS Offset (in)	N/A
N/A	Shared Landing?	N/A			
N/A	Gutter Ponding?	N/A	N/A	Gutter Slope (%)	N/A
N/A	Gutter Lip Ht (in)	N/A	N/A	Gutter X Slope (%)	N/A
N/A	Painted X Walk1?	No	N/A	Painted X Walk2?	Yes
	X Walk 1 Direction	To NE		X Walk 2 Direction	To NW
N/A	X Walk 1 Width (in)	N/A	N/A	X Walk 2 Width (in)	62.0
	X Walk 1 Slope (%)	3.0		X Walk 2 Slope (%)	3.0
	X Walk 1 X Slope (%)	3.7		X Walk 2 X Slope (%)	2.3

N/A	Ramp inside XWalk1?	N/A	N/A	Ramp inside XWalk2?	Yes
	Road Slope (%)	2.6	N/A	Clear Space?	N/A
	Road X Slope (%)	0.9	N/A	Clear Space to XWalk (in)	N/A
N/A	Any Obstructions?	N/A	N/A	Storm Grate/Utility Hazard?	N/A
	Obstruction Type			Storm Grate/Utility Type	
		N/A			N/A
			Yes	Surface Condition? (G/P)	Good

Remove & Replace Curb Ramp With Two New Directional Ramps or Equivalent.

Total Cost: \$ 3200.00
