Access Compliance Report

Public Rights-of-Way

(Curb Ramps)

Intersection ID: 14267	Main Street: CLANTON_RD	Cross Street: FARMER_ST	Location: NW
ADA ID: CFD964AE87DE	Ramp Type: Directional1	Initial Pass/Fail: Fail	Overall Compliance: No
		Severity Score: 25

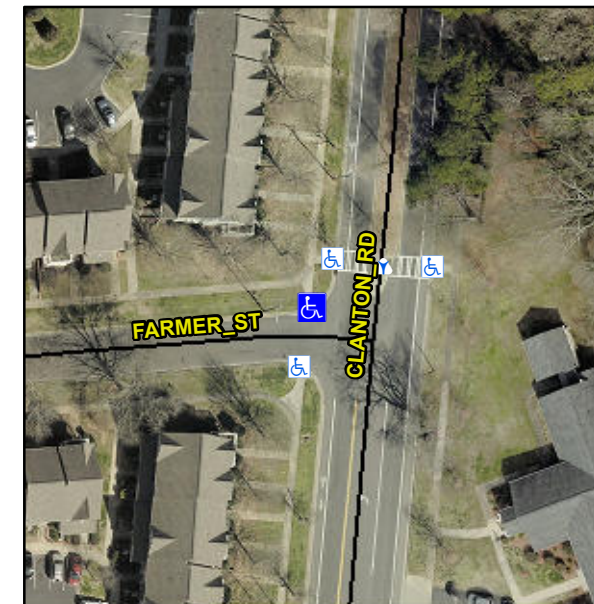
R304.2.2

Compliance	Description	Data	Compliance	Description	Data
N/A	Ramp Length (in)	67.0	N/A	Grade Break?	N/A
Yes	Ramp Width (in)	48.0	N/A	Grade Break Slope (%)	0.0
No	Ramp Slope (%)	17.6	N/A	Grade Break XSlope (%)	0.0
Yes	Ramp XSlope (%)	0.6			
N/A	Flare Type LT	N/A	N/A	Flare Type RT	N/A
N/A	Flare Slope LT (%)	N/A	N/A	Flare Slope RT (%)	0.0
N/A	Flare Traversable LT?	N/A	N/A	Flare Traversable RT?	N/A
N/A	Landing Length (in)	0.0	N/A	DWS Provided?	N/A
N/A	Landing Width (in)	0.0	N/A	DWS Contrast?	N/A
N/A	Landing Slope (%)	0.0	N/A	DWS Length (in)	N/A
N/A	Landing X Slope (%)	0.0	N/A	DWS Full Width?	N/A
N/A	Landing Curb? (Y/N)	N/A	N/A	DWS Offset LT (in)	N/A
N/A	Shared Landing?	N/A	N/A	DWS Offset RT (in)	N/A
N/A	Gutter Ponding?	0.0	N/A	Gutter Slope (%)	N/A
N/A	Gutter Lip Ht (in)	0.0	N/A	Gutter X Slope (%)	N/A
N/A	Painted X Walk1?	No		Road Slope (%)	0.3
	X Walk 1 Direction	To S		Road X Slope (%)	5.1
	X Walk 1 Width (in)	N/A		Clear Space?	N/A

X Walk 1 Slope (%)	0.3	N/A	Clear Space to XWalk (in)	N/A
	X Walk 1 X Slope (%)	5.1	N/A	Storm Grate/Utility Hazard?	N/A
N/A	Ramp inside XWalk1?	N/A		Storm Grate/Utility Type	
N/A	Any Obstructions?	N/A			N/A
	Obstruction Type		Yes	Surface Condition? (G/P)	Good
			N/A	Curb Slope (%)	10.3

Remove & Replace Entire Ramp.
