# Access Compliance Report

## Public Rights-of-Way

### (Curb Ramps)

Intersection ID: 45886	Main Street: BEN_LIVINGSTON_RD	Cross Street: OAK_ST	Location:	S
ADA ID: CFDA6886A100	Ramp Type: Perp	Initial Pass/Fail: Fail	Overall Compliance: No	Severity Score: 10
Codes/Mitigation Info/Possible Solution		Field Measurements/Component Compliance

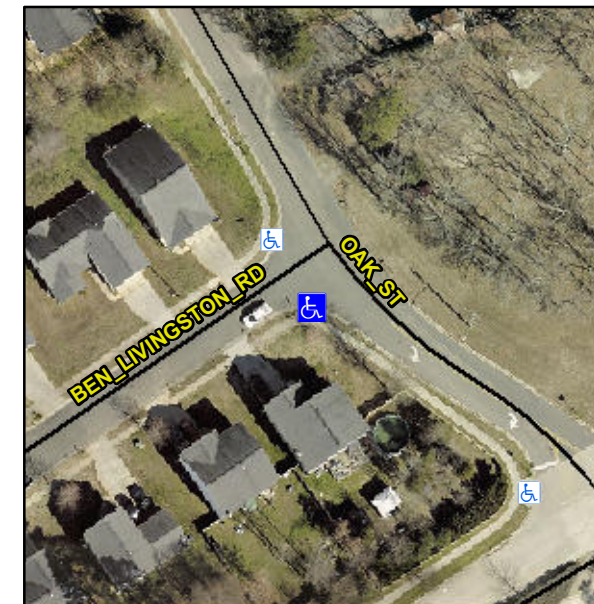
Compliance	Description	Data	Compliance	Description	Data
N/A	Ramp Length (in)	47.0	Yes	Ramp Slope (%)	7.5
No	Ramp Width (in)	47.5	No	Ramp XSlope (%)	3.4
N/A	Flare Type LT	N/A	N/A	Flare Type RT	N/A
N/A	Flare Slope LT (%)	N/A	N/A	Flare Slope RT (%)	N/A
N/A	Flare Traversable LT?	N/A	N/A	Flare Traversable RT?	N/A
N/A	Landing Length (in)	N/A	N/A	DWS Provided?	N/A
N/A	Landing Width (in)	N/A	N/A	DWS Contrast?	N/A
N/A	Landing Slope (%)	N/A	N/A	DWS Length (in)	N/A
N/A	Landing X Slope (%)	N/A	N/A	DWS Full Width?	N/A
N/A	Landing Curb? (Y/N)	N/A	N/A	DWS Offset (in)	N/A
N/A	Shared Landing?	N/A			
N/A	Gutter Ponding?	N/A	N/A	Gutter Slope (%)	N/A
N/A	Gutter Lip Ht (in)	N/A	N/A	Gutter X Slope (%)	N/A
N/A	Painted X Walk1?	No	N/A	Painted X Walk2?	N/A
	X Walk 1 Direction	To N		X Walk 2 Direction	N/A
N/A	X Walk 1 Width (in)	N/A	N/A	X Walk 2 Width (in)	N/A
	X Walk 1 Slope (%)	2.3		X Walk 2 Slope (%)	N/A
	X Walk 1 X Slope (%)	3.6		X Walk 2 X Slope (%)	N/A

N/A	Ramp inside XWalk1?	N/A	N/A	Ramp inside XWalk2?	N/A
	Road Slope (%)	N/A	N/A	Clear Space?	N/A
	Road X Slope (%)	N/A	N/A	Clear Space to XWalk (in)	N/A
N/A	Any Obstructions?	N/A	N/A	Storm Grate/Utility Hazard?	N/A
	Obstruction Type			Storm Grate/Utility Type	
		N/A			N/A
			Yes	Surface Condition? (G/P)	Good

Possible Solutions:

**Remove & Replace Entire Ramp.**

**R304.5.1, R304.5.3**
