Access Compliance Report

Public Rights-of-Way

(Curb Ramps)

Intersection ID: 12739	Main Street: N_MCDOWELL_ST	Cross Street: E_8TH_ST	Location:	N
ADA ID: CFE09FE52692	Ramp Type: PerpDiag	Initial Pass/Fail: Fail	Overall Compliance: No	Severity Score: 25

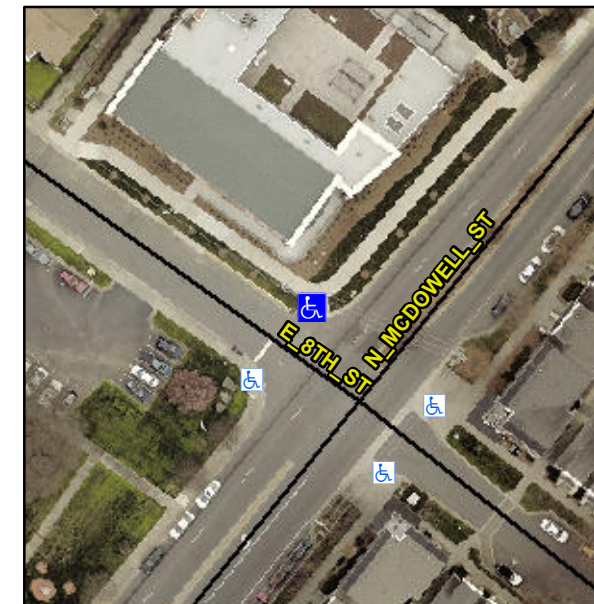
Not Found, R304.2.2, R304.5.3

Compliance	Description	Data	Compliance	Description	Data
N/A	Ramp Length (in)	70.0	No	Ramp Slope (%)	9.1
Yes	Ramp Width (in)	55.0	No	Ramp XSlope (%)	5.1
N/A	Flare Type LT	N/A	N/A	Flare Type RT	N/A
N/A	Flare Slope LT (%)	N/A	N/A	Flare Slope RT (%)	N/A
N/A	Flare Traversable LT?	N/A	N/A	Flare Traversable RT?	N/A
N/A	Landing Length (in)	N/A	N/A	DWS Provided?	N/A
N/A	Landing Width (in)	N/A	N/A	DWS Contrast?	N/A
N/A	Landing Slope (%)	N/A	N/A	DWS Length (in)	N/A
N/A	Landing X Slope (%)	N/A	N/A	DWS Full Width?	N/A
N/A	Landing Curb? (Y/N)	N/A	N/A	DWS Offset (in)	N/A
N/A	Shared Landing?	N/A			
N/A	Gutter Ponding?	N/A	N/A	Gutter Slope (%)	N/A
N/A	Gutter Lip Ht (in)	N/A	N/A	Gutter X Slope (%)	N/A
N/A	Painted X Walk1?	No	N/A	Painted X Walk2?	No
	X Walk 1 Direction	To SW		X Walk 2 Direction	To SE
N/A	X Walk 1 Width (in)	N/A	N/A	X Walk 2 Width (in)	N/A
	X Walk 1 Slope (%)	0.5		X Walk 2 Slope (%)	0.1
	X Walk 1 X Slope (%)	1.6		X Walk 2 X Slope (%)	1.2

N/A	Ramp inside XWalk1?	N/A	N/A	Ramp inside XWalk2?	N/A
	Road Slope (%)	1.8	N/A	Clear Space?	N/A
	Road X Slope (%)	0.6	N/A	Clear Space to XWalk (in)	N/A
N/A	Any Obstructions?	N/A	N/A	Storm Grate/Utility Hazard?	N/A
	Obstruction Type			Storm Grate/Utility Type	
		N/A			N/A
			Yes	Surface Condition? (G/P)	Good

Remove & Replace Curb Ramp With Two New Directional Ramps or Equivalent.
