# Access Compliance Report

## Public Rights-of-Way

### (Curb Ramps)

| Intersection ID: 10025543 | Main Street: E_TRADE_ST | Cross Street: N/A | Location: E |

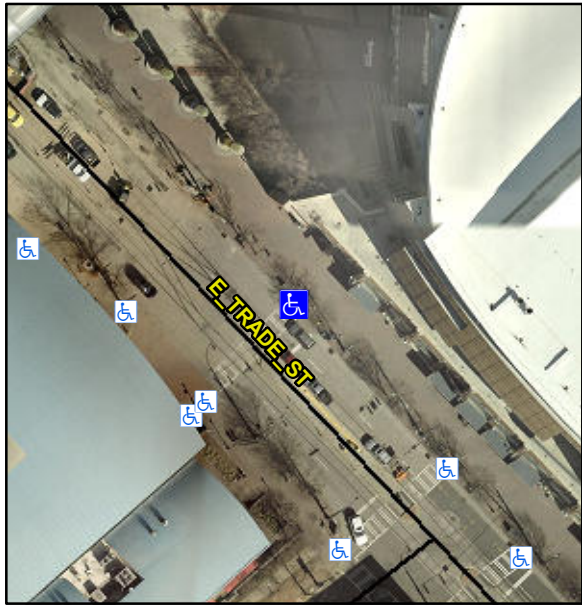
| ADA ID: CFE20B965BC0 | Ramp Type: Directional1 | Initial Pass/Fail: Fail | Overall Compliance: No |
| Severity Score: 12.5 | | | |

R304.2.2

| Compliance | Description | Data | Compliance | Description | Data |
|---|---|---|---|---|---|
| No | Ramp Slope (%) | 8.4 | N/A | Grade Break XSlope (%) | 0.0 |

Remove & Replace Entire Ramp.

1600.00
