# Access Compliance Report

## Public Rights-of-Way

### (Curb Ramps)

Intersection ID: 15446	Main Street: BARRINGER_DR	Cross Street: BLAIRHILL_RD	Location: NE
ADA ID: CFE23C0854A2	Ramp Type: PerpDiag	Initial Pass/Fail: Pass	Overall Compliance: No
Severity Score: 7.75			
Codes/Mitigation Info/Possible Solution		Field Measurements/Component Compliance

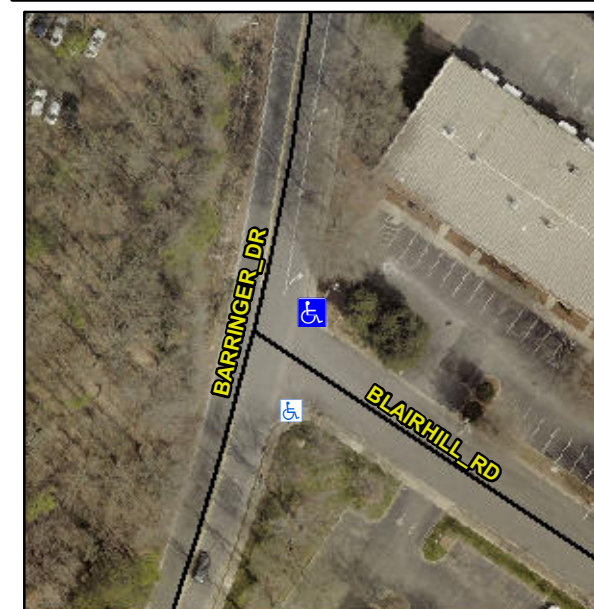
**Not Found, R304.5.3, R304.2.1, R304.2.2-Perp, R304.3.2-Para, R305.2, R302.7.2**

Compliance	Description	Data	Compliance	Description	Data
N/A	Ramp Length (in)	36.0	Yes	Ramp Slope (%)	5.3
Yes	Ramp Width (in)	48.0	No	Ramp XSlope (%)	2.3
N/A	Flare Type LT	Sloped	N/A	Flare Type RT	N/A
N/A	Flare Slope LT (%)	0.5	Yes	Flare Slope RT (%)	2.3
N/A	Flare Traversable LT?	Yes	N/A	Flare Traversable RT?	Yes
No	Landing Length (in)	24.0	Yes	DWS Provided?	Yes
Yes	Landing Width (in)	48.0	Yes	DWS Contrast?	Yes
No	Landing Slope (%)	3.6	Yes	DWS Length (in)	24.0
Yes	Landing X Slope (%)	1.5	Yes	DWS Full Width?	Yes
N/A	Landing Curb? (Y/N)	No	No	DWS Offset (in)	4.5
N/A	Shared Landing?	No			
Yes	Gutter Ponding?	No	Yes	Gutter Slope (%)	4.6
No	Gutter Lip Ht (in)	0.5	Yes	Gutter X Slope (%)	1.5
N/A	Painted X Walk1?	No	N/A	Painted X Walk2?	No
	X Walk 1 Direction	To W		X Walk 2 Direction	To S
N/A	X Walk 1 Width (in)	N/A	N/A	X Walk 2 Width (in)	N/A
	X Walk 1 Slope (%)	2.9		X Walk 2 Slope (%)	5.6
	X Walk 1 X Slope (%)	3.1		X Walk 2 X Slope (%)	1.2

N/A	Ramp inside XWalk1?	N/A	N/A	Ramp inside XWalk2?	N/A
	Road Slope (%)	0.4	N/A	Clear Space?	Yes
	Road X Slope (%)	5.1	N/A	Clear Space to XWalk (in)	N/A
Yes	Any Obstructions?	No	Yes	Storm Grate/Utility Hazard?	No
	Obstruction Type			Storm Grate/Utility Type	
		N/A			N/A
			Yes	Surface Condition? (G/P)	Good

**Remove & Replace Curb Ramp With Two New Directional Ramps or Equivalent.**

Total Cost: \$ 3200.00
