Access Compliance Report Public Rights-of-Way (Curb Ramps)

Main Street: PIEDMONT ROW DR SOUTH Cross Street: N/A Location: Intersection ID: 10034403 NE

Ramp Type: PerpDiag Initial Pass/Fail: Fail **Overall Compliance: No** Severity Score: 33.75 **ADA ID: CFE6EF8CD9AA**

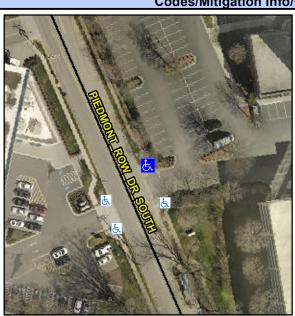
Not Found, R304.5.1, R304.2.2, R304.5.3

Compl	iance Description	Data	Compl	iance	Description	Data
N/A	Ramp Length (in)	47.0	No	Ramp	Slope (%)	9.1
No	Ramp Width (in)	42.0	No	Ramp	XSlope (%)	5.4
N/A	Flare Type LT	N/A	N/A	Flare	Type RT	N/A
N/A	Flare Slope LT (%)	N/A	N/A	Flare	Slope RT (%)	N/A
N/A	Flare Traversable LT?	N/A	N/A	Flare	Traversable RT?	N/A
N/A	Landing Length (in)	N/A	N/A	DWS	Provided?	N/A
N/A	Landing Width (in)	N/A	N/A	DWS	Contrast?	N/A
N/A	Landing Slope (%)	N/A	N/A	DWS	Length (in)	N/A
N/A	Landing X Slope (%)	N/A	N/A	DWS	Full Width?	N/A
N/A	Landing Curb? (Y/N)	N/A	N/A	DWS	Offset (in)	N/A
N/A	Shared Landing?	N/A				
N/A	Gutter Ponding?	N/A	N/A	Gutte	er Slope (%)	N/A
N/A	Gutter Lip Ht (in)	N/A	N/A	Gutte	er X Slope (%)	N/A
N/A	Painted X Walk1?	No	N/A	Paint	ed X Walk2?	No
	X Walk 1 Direction	To SW		X Wa	lk 2 Direction	To SE
N/A	X Walk 1 Width (in)	N/A	N/A	X Wa	lk 2 Width (in)	N/A
	X Walk 1 Slope (%)	4.3		X Wa	lk 2 Slope (%)	4.7
	X Walk 1 X Slope (%)	0.8		X Wa	lk 2 X Slope (%)	5.4

N/A	Ramp inside XWalk1?	N/A	N/A	Ram	o inside XWalk2?	N/A
	Road Slope (%)	4.4	N/A	Clear	Space?	N/A
	Road X Slope (%)	0.2	N/A	Clear	Space to XWalk (in)	N/A
N/A	Any Obstructions?	N/A	N/A	Storn	n Grate/Utility Hazard?	N/A
	Obstruction Type			Storn	n Grate/Utility Type	
		N/A				N/A

Remove & Replace Curb Ramp With Two New Directional Ramps or Equivalent.
