Access Compliance Report

Public Rights-of-Way

(Curb Ramps)

Intersection ID: 45778	Main Street: CARVER FALLS RD	Cross Street: WINDING RIVER DR	Location: SE
ADA ID: CFEBF8F2CF15	Ramp Type: PerpDiag	Initial Pass/Fail: Fail	Overall Compliance: No
		Severity Score: 21.25

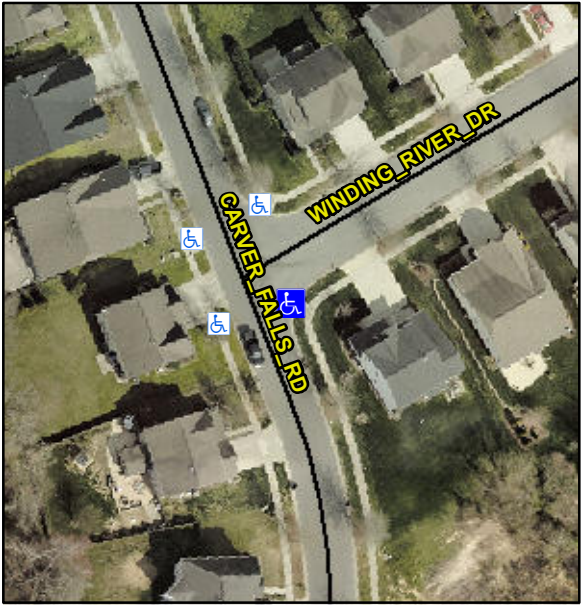
<p>Street 1 Name WINDING RIVER DR</p> <p>Stop Condition-Street 2 StopSign</p> <p>Street 2 Name CARVER FALLS RD</p> <p>Stop Condition-Street 1 None</p>	<p>Possible Solutions:</p> <p>Remove & Replace Curb Ramp With Two New Directional Ramps or Equivalent.</p> <p>Surveyor Notes:</p> <p>N/A</p> <p>PROW/ADA:</p> <p>R304.5.1, R304.5.3</p>	<p>Total Cost:</p> <p>\$ 3200.00</p>			
			Compliance	Description	Data
			Compliance	Description	Data
			N/A	Ramp Length (in)	73.0
			No	Ramp Width (in)	44.5
			N/A	Flare Type LT	N/A
			N/A	Flare Slope LT (%)	N/A
			N/A	Flare Traversable LT?	N/A
			N/A	Landing Length (in)	N/A
			N/A	Landing Width (in)	N/A
			N/A	Landing Slope (%)	N/A
			N/A	Landing X Slope (%)	N/A
			N/A	Landing Curb? (Y/N)	N/A
			N/A	Shared Landing?	N/A
			N/A	Gutter Ponding?	N/A
			N/A	Gutter Lip Ht (in)	N/A
			N/A	Painted X Walk1?	No

X Walk 1 Direction	To N
			N/A	X Walk 1 Width (in)	N/A
				X Walk 1 Slope (%)	0.2
				X Walk 1 X Slope (%)	4.7
			N/A	Ramp inside XWalk1?	N/A
				Road Slope (%)	4.4
				Road X Slope (%)	3.6
			N/A	Any Obstructions?	N/A
				Obstruction Type	
			N/A		N/A
			Yes	Surface Condition? (G/P)	Good
