Access Compliance Report

Public Rights-of-Way

(Curb Ramps)

Intersection ID: 14509	Main Street: CARONIA_ST	Cross Street: HIRAM_ST	Location: SE
ADA ID: CFF3633D3551	Ramp Type: PerpDiag	Initial Pass/Fail: Fail	Overall Compliance: No
Severity Score: 33.75			
Codes/Mitigation Info/Possible Solution		Field Measurements/Component Compliance

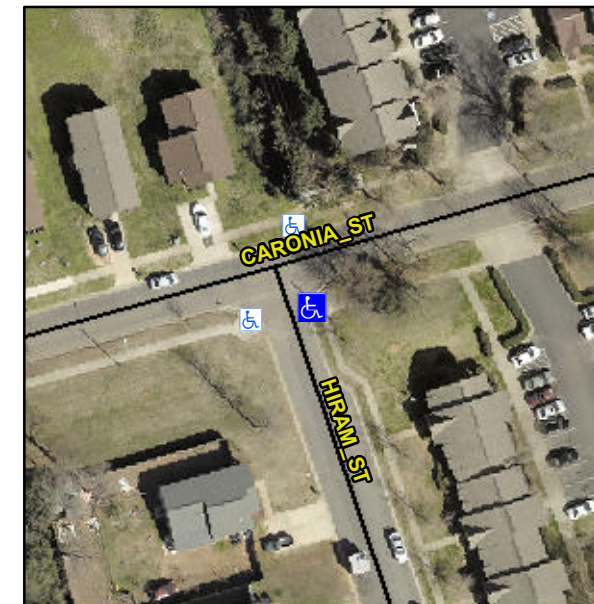
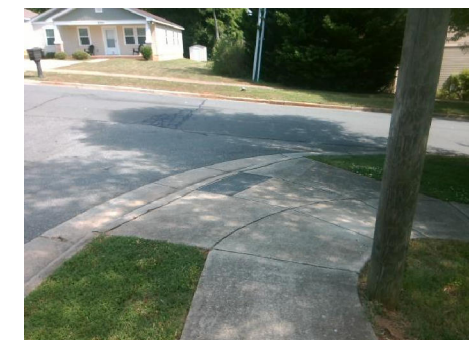
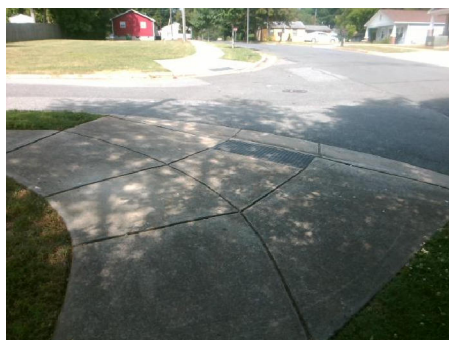
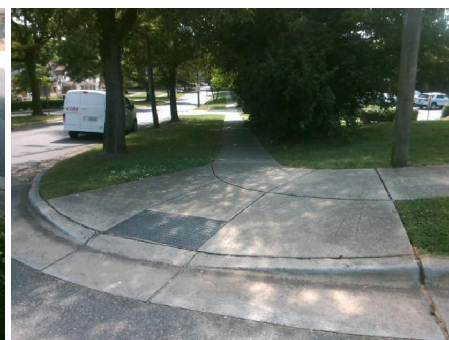
Not Found, R304.5.1, R304.5.3

Compliance	Description	Data	Compliance	Description	Data
N/A	Ramp Length (in)	60.0	Yes	Ramp Slope (%)	5.7
No	Ramp Width (in)	46.5	No	Ramp XSlope (%)	10.3
N/A	Flare Type LT	N/A	N/A	Flare Type RT	N/A
N/A	Flare Slope LT (%)	N/A	N/A	Flare Slope RT (%)	N/A
N/A	Flare Traversable LT?	N/A	N/A	Flare Traversable RT?	N/A
N/A	Landing Length (in)	N/A	N/A	DWS Provided?	N/A
N/A	Landing Width (in)	N/A	N/A	DWS Contrast?	N/A
N/A	Landing Slope (%)	N/A	N/A	DWS Length (in)	N/A
N/A	Landing X Slope (%)	N/A	N/A	DWS Full Width?	N/A
N/A	Landing Curb? (Y/N)	N/A	N/A	DWS Offset (in)	N/A
N/A	Shared Landing?	N/A			
N/A	Gutter Ponding?	N/A	N/A	Gutter Slope (%)	N/A
N/A	Gutter Lip Ht (in)	N/A	N/A	Gutter X Slope (%)	N/A
N/A	Painted X Walk1?	No	N/A	Painted X Walk2?	No
	X Walk 1 Direction	To N		X Walk 2 Direction	To W
N/A	X Walk 1 Width (in)	N/A	N/A	X Walk 2 Width (in)	N/A
	X Walk 1 Slope (%)	5.3		X Walk 2 Slope (%)	1.8
	X Walk 1 X Slope (%)	7.3		X Walk 2 X Slope (%)	3.8

N/A	Ramp inside XWalk1?	N/A	N/A	Ramp inside XWalk2?	N/A
	Road Slope (%)	9.1	N/A	Clear Space?	N/A
	Road X Slope (%)	2.3	N/A	Clear Space to XWalk (in)	N/A
N/A	Any Obstructions?	N/A	N/A	Storm Grate/Utility Hazard?	N/A
	Obstruction Type			Storm Grate/Utility Type	
		N/A			N/A
		Yes		Surface Condition? (G/P)	Good

Remove & Replace Curb Ramp With Two New Directional Ramps or Equivalent.
