Access Compliance Report

Public Rights-of-Way

(Curb Ramps)

Intersection ID: 9632	Main Street: BOXFORD_CT	Cross Street: FLOWERS_CT	Location: SE
ADA ID: CFF810DAE3F9	Ramp Type: Perp	Initial Pass/Fail: Fail	Overall Compliance: No
Severity Score: 21.25			
Codes/Mitigation Info/Possible Solution		Field Measurements/Component Compliance

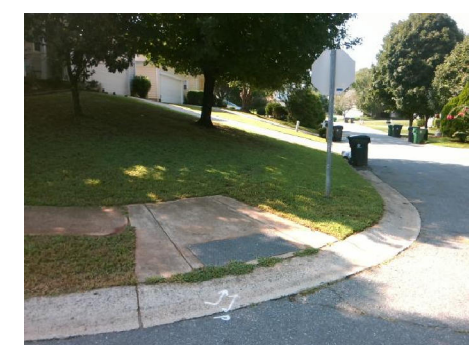
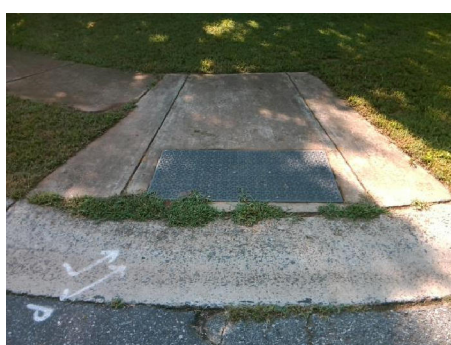
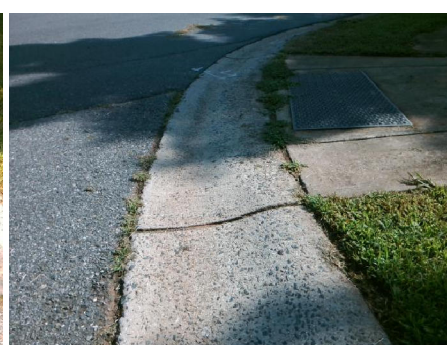
Not Found, R304.5.1, R304.2.2

Compliance	Description	Data	Compliance	Description	Data
N/A	Ramp Length (in)	95.5	No	Ramp Slope (%)	8.5
No	Ramp Width (in)	43.5	Yes	Ramp XSlope (%)	0.8
N/A	Flare Type LT	N/A	N/A	Flare Type RT	N/A
N/A	Flare Slope LT (%)	N/A	N/A	Flare Slope RT (%)	N/A
N/A	Flare Traversable LT?	N/A	N/A	Flare Traversable RT?	N/A
N/A	Landing Length (in)	N/A	N/A	DWS Provided?	N/A
N/A	Landing Width (in)	N/A	N/A	DWS Contrast?	N/A
N/A	Landing Slope (%)	N/A	N/A	DWS Length (in)	N/A
N/A	Landing X Slope (%)	N/A	N/A	DWS Full Width?	N/A
N/A	Landing Curb? (Y/N)	N/A	N/A	DWS Offset (in)	N/A
N/A	Shared Landing?	N/A			
N/A	Gutter Ponding?	N/A	N/A	Gutter Slope (%)	N/A
N/A	Gutter Lip Ht (in)	0.5	N/A	Gutter X Slope (%)	N/A
N/A	Painted X Walk1?	No	N/A	Painted X Walk2?	N/A
	X Walk 1 Direction	To W		X Walk 2 Direction	N/A
N/A	X Walk 1 Width (in)	N/A	N/A	X Walk 2 Width (in)	N/A
	X Walk 1 Slope (%)	1.6		X Walk 2 Slope (%)	N/A
	X Walk 1 X Slope (%)	1.7		X Walk 2 X Slope (%)	N/A

N/A	Ramp inside XWalk1?	N/A	N/A	Ramp inside XWalk2?	N/A
	Road Slope (%)	N/A	N/A	Clear Space?	N/A
	Road X Slope (%)	N/A	N/A	Clear Space to XWalk (in)	N/A
N/A	Any Obstructions?	N/A	N/A	Storm Grate/Utility Hazard?	N/A
	Obstruction Type			Storm Grate/Utility Type	
		N/A			N/A
			Yes	Surface Condition? (G/P)	Good

Remove & Replace Entire Ramp.
