Access Compliance Report

Public Rights-of-Way

(Curb Ramps)

Intersection ID: 15247	Main Street: E_INDEPENDENCE_BV	Cross Street: EASTWAY_DR_RA	Location: NW
ADA ID: CFF8F75DBBF9	Ramp Type: Perp	Initial Pass/Fail: Fail	Overall Compliance: No
Severity Score: 13.75			
Codes/Mitigation Info/Possible Solution		Field Measurements/Component Compliance

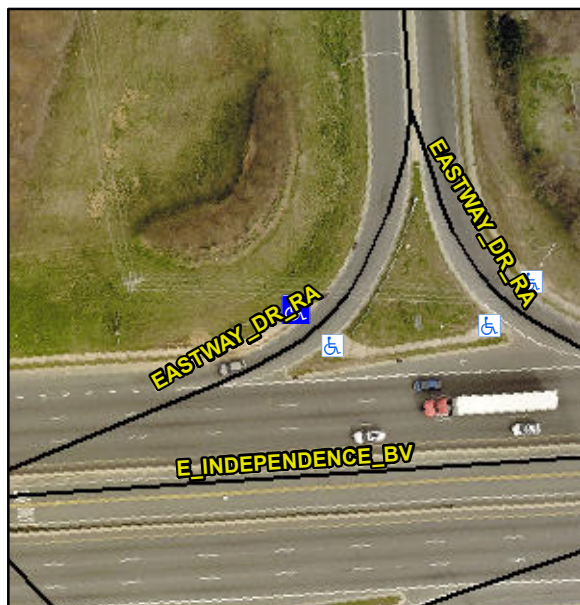
Not Found, R304.2.2, R304.5.3

Compliance	Description	Data	Compliance	Description	Data
N/A	Ramp Length (in)	78.0	No	Ramp Slope (%)	10.5
Yes	Ramp Width (in)	61.5	No	Ramp XSlope (%)	3.4
N/A	Flare Type LT	N/A	N/A	Flare Type RT	N/A
N/A	Flare Slope LT (%)	N/A	N/A	Flare Slope RT (%)	N/A
N/A	Flare Traversable LT?	N/A	N/A	Flare Traversable RT?	N/A
N/A	Landing Length (in)	N/A	N/A	DWS Provided?	N/A
N/A	Landing Width (in)	N/A	N/A	DWS Contrast?	N/A
N/A	Landing Slope (%)	N/A	N/A	DWS Length (in)	N/A
N/A	Landing X Slope (%)	N/A	N/A	DWS Full Width?	N/A
N/A	Landing Curb? (Y/N)	N/A	N/A	DWS Offset (in)	N/A
N/A	Shared Landing?	N/A			
N/A	Gutter Ponding?	N/A	N/A	Gutter Slope (%)	N/A
N/A	Gutter Lip Ht (in)	N/A	N/A	Gutter X Slope (%)	N/A
N/A	Painted X Walk1?	No	N/A	Painted X Walk2?	N/A
	X Walk 1 Direction	To SE		X Walk 2 Direction	N/A
N/A	X Walk 1 Width (in)	N/A	N/A	X Walk 2 Width (in)	N/A
	X Walk 1 Slope (%)	5.8		X Walk 2 Slope (%)	N/A
	X Walk 1 X Slope (%)	1.6		X Walk 2 X Slope (%)	N/A

N/A	Ramp inside XWalk1?	N/A	N/A	Ramp inside XWalk2?	N/A
	Road Slope (%)	N/A	N/A	Clear Space?	N/A
	Road X Slope (%)	N/A	N/A	Clear Space to XWalk (in)	N/A
N/A	Any Obstructions?	N/A	N/A	Storm Grate/Utility Hazard?	N/A
	Obstruction Type			Storm Grate/Utility Type	
		N/A			N/A
		Yes		Surface Condition? (G/P)	Good

Possible Solutions:

Remove & Replace Entire Ramp.
