Access Compliance Report Public Rights-of-Way (Curb Ramps)

Interpretion ID: 2041 Main Street: OD//IS ST				Stroot		Logation	SW/			
Intersection ID: 8941	Main Street: ORVIS_ST				RUSSELL_AV	Location:	SW			
ADA ID: CFFBE46F7C12 Ramp Type: Perp			Initial P	Initial Pass/Fail: Fail Overall Compliance: No				o Severity Score:	1.25	
Codes/Mitigation Info/Possible Solution				Field Measurements/Component Compliance

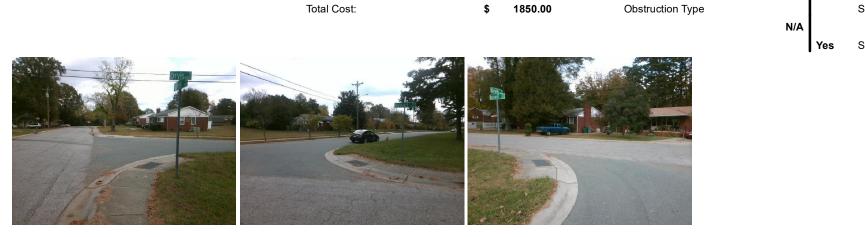
1. 1. 1. 1. 1. 1.	Carlos Carlos	Possible Solutions:		Compliance Description			Data Compliance Description			
	S. Past	Remove & Replace Entire Ramp).	N/A	Ramp Length (in)	60.0	Yes	Ramp Slope (%)	6.8	
The set of the				Yes	Ramp Width (in)	48.0	No	Ramp XSlope (%)	2.9	
				N/A	Flare Type LT	N/A	N/A	Flare Type RT	N/A	
MAN AND AND AND AND AND AND AND AND AND A	1			N/A	Flare Slope LT (%)	N/A	N/A	Flare Slope RT (%)	N/A	
				N/A	Flare Traversable LT?	N/A	N/A	Flare Traversable RT?	N/A	
RUSSELLAN				N/A	Landing Length (in)	N/A	N/A	DWS Provided?	N/A	
LIUCCOLL	M	Surveyor Notes:		N/A	Landing Width (in)	N/A	N/A	DWS Contrast?	N/A	
د. جرار در ا	STATE OF THE	N/A		N/A	Landing Slope (%)	N/A	N/A	DWS Length (in)	N/A	
	and the second second			N/A	Landing X Slope (%)	N/A	N/A	DWS Full Width?	N/A	
A	T.Y			N/A	Landing Curb? (Y/N)	N/A	N/A	DWS Offset (in)	N/A	
	1			N/A	Shared Landing?	N/A				
	Level .	PROW/ADA:		N/A	Gutter Ponding?	N/A	N/A	Gutter Slope (%)	N/A
