Access Compliance Report

Public Rights-of-Way

(Curb Ramps)

| Intersection ID: 13263 | Main Street: MCCLINTOCK_RD | Cross Street: THE_PLAZA | Location: NE |

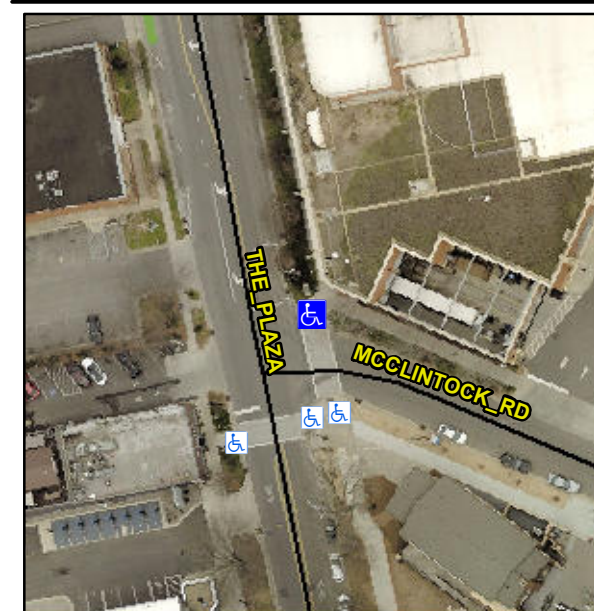
| ADA ID: D0209FBCD3E2 | Ramp Type: Perp | Initial Pass/Fail: Fail | Overall Compliance: No |
| Severity Score: 12.5 | | | |

R304.2.2

| Compliance | Description | Data | Compliance | Description | Data |
|---|---|---|---|---|---|
| N/A | Ramp Length (in) | 95.0 | No | Ramp Slope (%) | 8.4 |

Remove & Replace Entire Ramp.

\$ 1850.00

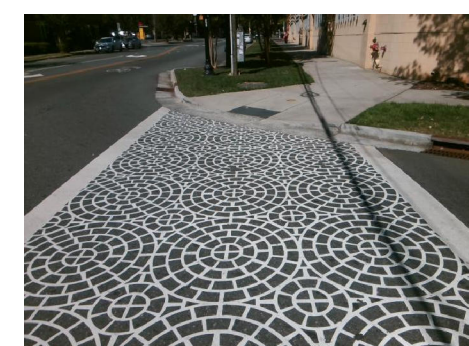
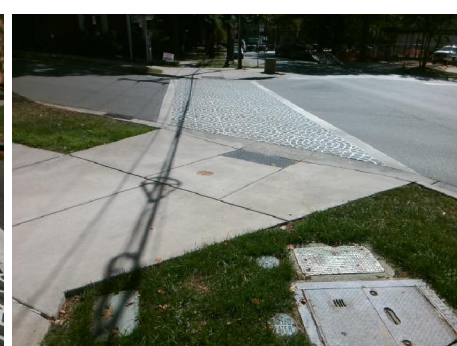
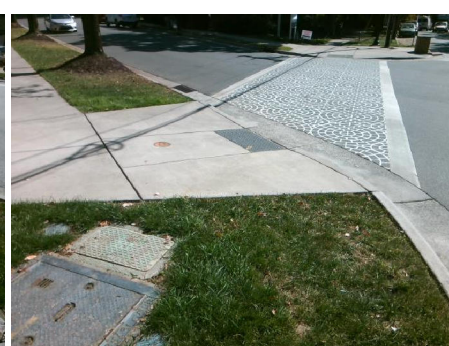
| Compliance | Description | Data | Compliance | Description | Data |
|---|---|---|---|---|---|
| | | | Yes | Surface Condition? (G/P) | Good |
