# Access Compliance Report

## Public Rights-of-Way

### (Curb Ramps)

| Intersection ID: 53091 | Main Street: DEERHURST_LN | Cross Street: DEERFIELD_MANOR_DR | Location: E |

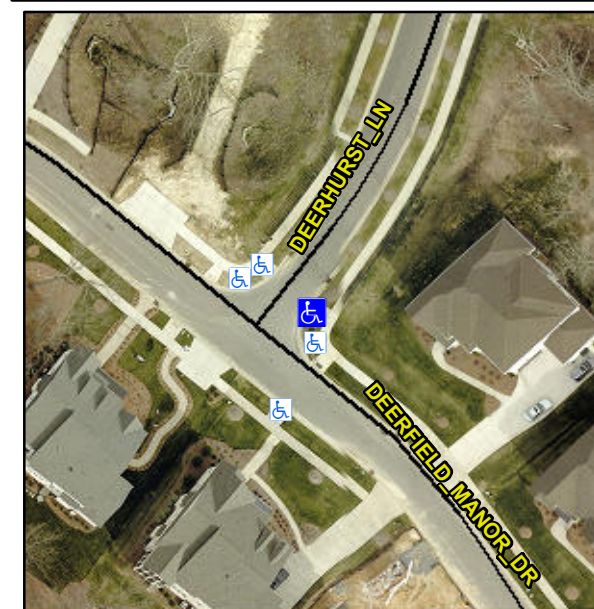
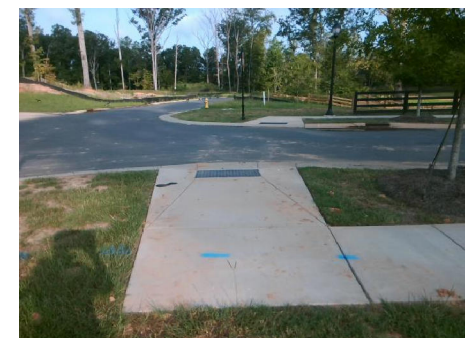
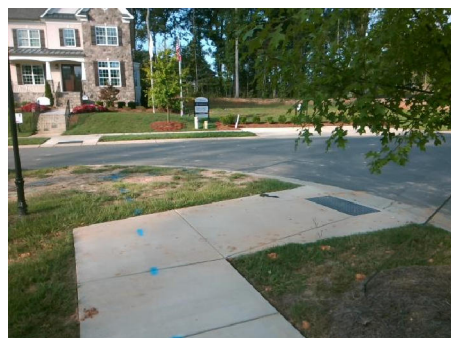
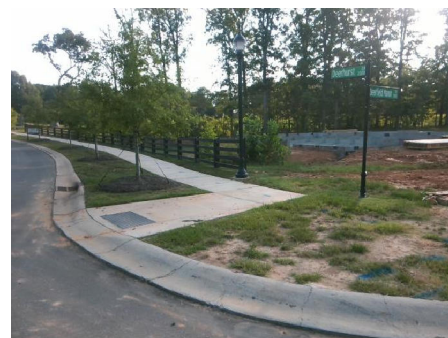
| ADA ID: D02B6A4C06E3 | Ramp Type: BlendTrans1 | Initial Pass/Fail: Fail | Overall Compliance: No |

**CURB LIP 1.5**

**R304.5.1**

| Compliance | Description | Data | Compliance | Description | Data |
|---|---|---|---|---|---|
| No | Ramp Width (in) | 47.0 | Yes | BlendTrans XSlope (%) | 1.1 |

**Remove & Replace Curb Ramp With Two New Directional Ramps or Equivalent.**
