Access Compliance Report

Public Rights-of-Way

(Curb Ramps)

Intersection ID: 14069	Main Street: CLARICE_AV	Cross Street: E_8TH_ST	Location:	N
ADA ID: D02BE6EDEC87	Ramp Type: PerpDiag	Initial Pass/Fail: Fail	Overall Compliance: No	Severity Score: 12.5

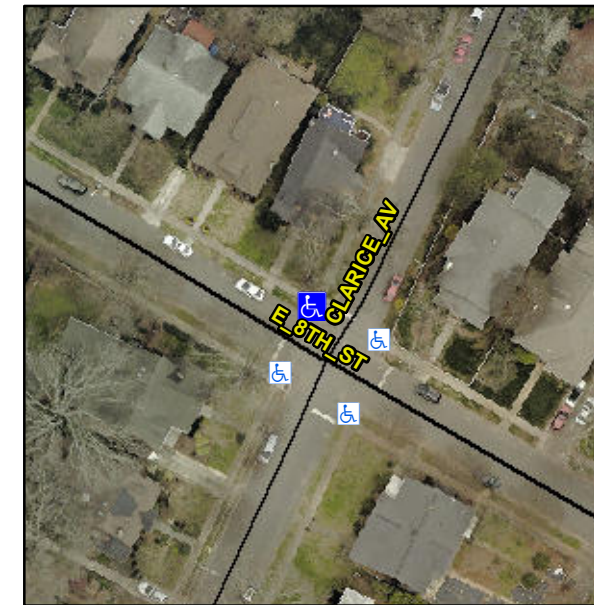
Compliance	Description	Data	Compliance	Description	Data
N/A	Ramp Length (in)	61.0	No	Ramp Slope (%)	11.1
Yes	Ramp Width (in)	48.0	Yes	Ramp XSlope (%)	0.8
N/A	Flare Type LT	N/A	N/A	Flare Type RT	N/A
N/A	Flare Slope LT (%)	N/A	N/A	Flare Slope RT (%)	N/A
N/A	Flare Traversable LT?	N/A	N/A	Flare Traversable RT?	N/A
N/A	Landing Length (in)	N/A	N/A	DWS Provided?	N/A
N/A	Landing Width (in)	N/A	N/A	DWS Contrast?	N/A
N/A	Landing Slope (%)	N/A	N/A	DWS Length (in)	N/A
N/A	Landing X Slope (%)	N/A	N/A	DWS Full Width?	N/A
N/A	Landing Curb? (Y/N)	N/A	N/A	DWS Offset (in)	N/A
N/A	Shared Landing?	N/A			
N/A	Gutter Ponding?	N/A	N/A	Gutter Slope (%)	N/A
N/A	Gutter Lip Ht (in)	N/A	N/A	Gutter X Slope (%)	N/A
N/A	Painted X Walk1?	No	N/A	Painted X Walk2?	No
	X Walk 1 Direction	To SW		X Walk 2 Direction	To SE
N/A	X Walk 1 Width (in)	N/A	N/A	X Walk 2 Width (in)	N/A
	X Walk 1 Slope (%)	1.5		X Walk 2 Slope (%)	1.7
	X Walk 1 X Slope (%)	1.8		X Walk 2 X Slope (%)	1.1

N/A	Ramp inside XWalk1?	N/A	N/A	Ramp inside XWalk2?	N/A
	Road Slope (%)	1.5	N/A	Clear Space?	N/A
	Road X Slope (%)	4.3	N/A	Clear Space to XWalk (in)	N/A
N/A	Any Obstructions?	N/A	N/A	Storm Grate/Utility Hazard?	N/A
	Obstruction Type			Storm Grate/Utility Type	
		N/A			N/A
			Yes	Surface Condition? (G/P)	Good

Remove & Replace Curb Ramp With Two New Directional Ramps or Equivalent.

Not Found, R304.2.2
