Access Compliance Report

Public Rights-of-Way

(Curb Ramps)

Intersection ID: 28055	Main Street: STRATHMOOR_DR	Cross Street: PROVIDENCE_RD_WEST	Location: NW
ADA ID: D02C15B236D6	Ramp Type: Perp	Initial Pass/Fail: Fail	Overall Compliance: No
Severity Score: 25			
Codes/Mitigation Info/Possible Solution		Field Measurements/Component Compliance

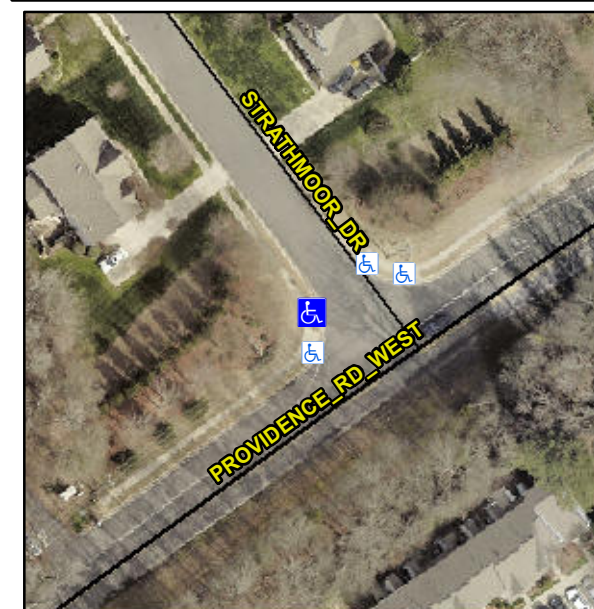
Not Found, R304.2.2, R304.5.3

Compliance	Description	Data	Compliance	Description	Data
N/A	Ramp Length (in)	49.0	No	Ramp Slope (%)	11.4
Yes	Ramp Width (in)	48.0	No	Ramp XSlope (%)	6.2
N/A	Flare Type LT	N/A	N/A	Flare Type RT	N/A
N/A	Flare Slope LT (%)	N/A	N/A	Flare Slope RT (%)	N/A
N/A	Flare Traversable LT?	N/A	N/A	Flare Traversable RT?	N/A
N/A	Landing Length (in)	N/A	N/A	DWS Provided?	N/A
N/A	Landing Width (in)	N/A	N/A	DWS Contrast?	N/A
N/A	Landing Slope (%)	N/A	N/A	DWS Length (in)	N/A
N/A	Landing X Slope (%)	N/A	N/A	DWS Full Width?	N/A
N/A	Landing Curb? (Y/N)	N/A	N/A	DWS Offset (in)	N/A
N/A	Shared Landing?	N/A			
N/A	Gutter Ponding?	N/A	N/A	Gutter Slope (%)	N/A
N/A	Gutter Lip Ht (in)	N/A	N/A	Gutter X Slope (%)	N/A
N/A	Painted X Walk1?	No	N/A	Painted X Walk2?	N/A
	X Walk 1 Direction	To NE		X Walk 2 Direction	N/A
N/A	X Walk 1 Width (in)	N/A	N/A	X Walk 2 Width (in)	N/A
	X Walk 1 Slope (%)	0.8		X Walk 2 Slope (%)	N/A
	X Walk 1 X Slope (%)	4.7		X Walk 2 X Slope (%)	N/A

N/A	Ramp inside XWalk1?	N/A	N/A	Ramp inside XWalk2?	N/A
	Road Slope (%)	N/A	N/A	Clear Space?	N/A
	Road X Slope (%)	N/A	N/A	Clear Space to XWalk (in)	N/A
N/A	Any Obstructions?	N/A	N/A	Storm Grate/Utility Hazard?	N/A
	Obstruction Type			Storm Grate/Utility Type	
		N/A			N/A
			Yes	Surface Condition? (G/P)	Good

Remove & Replace Entire Ramp.
