Access Compliance Report

Public Rights-of-Way

(Curb Ramps)

Intersection ID: 45174	Main Street: LINDEN_TREE_LN	Cross Street: SOCIETY_ST	Location: SW
ADA ID: D030B965207B	Ramp Type: Perp	Initial Pass/Fail: Fail	Overall Compliance: No
		Severity Score: 25

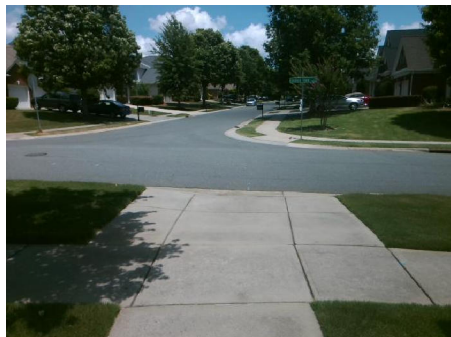
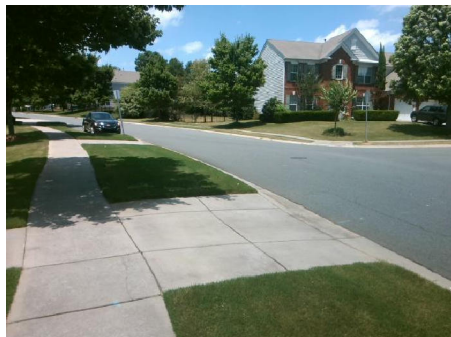
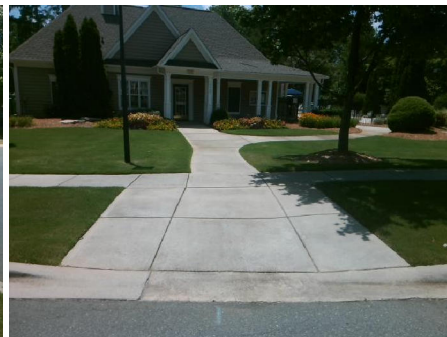
Not Found, R304.2.2, R304.5.3

Compliance	Description	Data	Compliance	Description	Data
N/A	Ramp Length (in)	112.0	No	Ramp Slope (%)	8.4
Yes	Ramp Width (in)	59.0	No	Ramp XSlope (%)	5.2
N/A	Flare Type LT	N/A	N/A	Flare Type RT	N/A
N/A	Flare Slope LT (%)	N/A	N/A	Flare Slope RT (%)	N/A
N/A	Flare Traversable LT?	N/A	N/A	Flare Traversable RT?	N/A
N/A	Landing Length (in)	N/A	N/A	DWS Provided?	N/A
N/A	Landing Width (in)	N/A	N/A	DWS Contrast?	N/A
N/A	Landing Slope (%)	N/A	N/A	DWS Length (in)	N/A
N/A	Landing X Slope (%)	N/A	N/A	DWS Full Width?	N/A
N/A	Landing Curb? (Y/N)	N/A	N/A	DWS Offset (in)	N/A
N/A	Shared Landing?	N/A			
N/A	Gutter Ponding?	N/A	N/A	Gutter Slope (%)	N/A
N/A	Gutter Lip Ht (in)	N/A	N/A	Gutter X Slope (%)	N/A
N/A	Painted X Walk1?	No	N/A	Painted X Walk2?	N/A
	X Walk 1 Direction	To NE		X Walk 2 Direction	N/A
N/A	X Walk 1 Width (in)	N/A	N/A	X Walk 2 Width (in)	N/A
	X Walk 1 Slope (%)	1.6		X Walk 2 Slope (%)	N/A
	X Walk 1 X Slope (%)	1.9		X Walk 2 X Slope (%)	N/A

N/A	Ramp inside XWalk1?	N/A	N/A	Ramp inside XWalk2?	N/A
	Road Slope (%)	N/A	N/A	Clear Space?	N/A
	Road X Slope (%)	N/A	N/A	Clear Space to XWalk (in)	N/A
N/A	Any Obstructions?	N/A	N/A	Storm Grate/Utility Hazard?	N/A
	Obstruction Type			Storm Grate/Utility Type	
		N/A			N/A
			Yes	Surface Condition? (G/P)	Good

Remove & Replace Entire Ramp.
