Access Compliance Report

Public Rights-of-Way

(Curb Ramps)

Intersection ID: N/A	Main Street: SOUTH_BV	Cross Street: N/A	Location: N
ADA ID: D031C3C33F46	Ramp Type: Directional1	Initial Pass/Fail: Fail	Overall Compliance: No
		Severity Score: 1.25

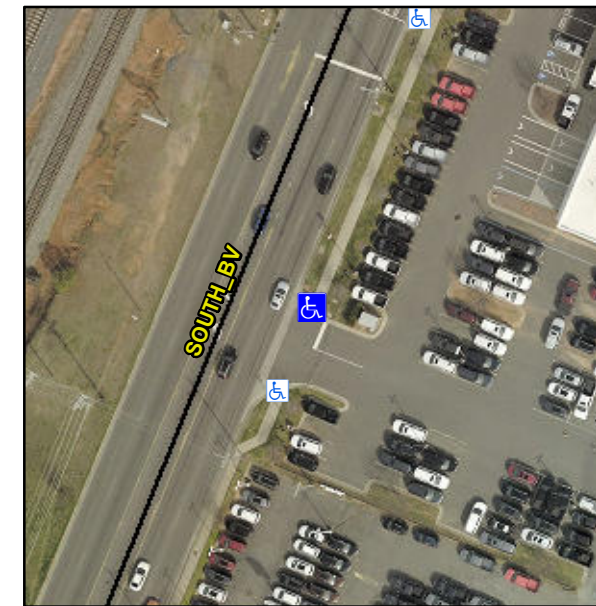
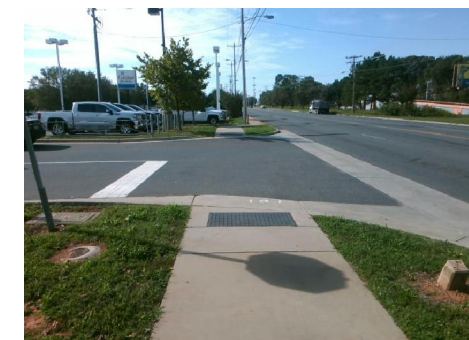
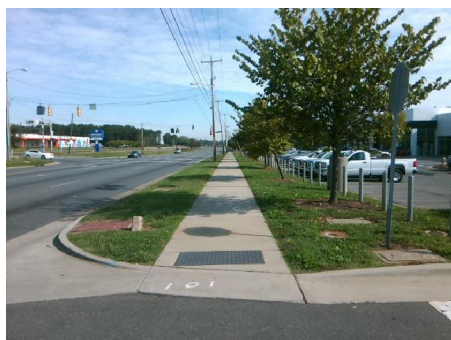
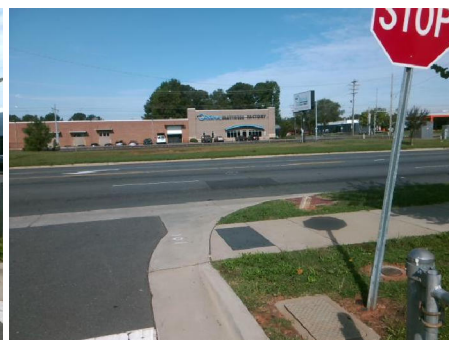
Compliance	Description	Data	Compliance	Description	Data
N/A	Ramp Length (in)	56.0	N/A	Grade Break?	N/A
Yes	Ramp Width (in)	48.0	N/A	Grade Break Slope (%)	0.0
Yes	Ramp Slope (%)	0.2	N/A	Grade Break XSlope (%)	0.0
No	Ramp XSlope (%)	2.5			
N/A	Flare Type LT	N/A	N/A	Flare Type RT	N/A
N/A	Flare Slope LT (%)	N/A	N/A	Flare Slope RT (%)	0.0
N/A	Flare Traversable LT?	N/A	N/A	Flare Traversable RT?	N/A
N/A	Landing Length (in)	0.0	N/A	DWS Provided?	N/A
N/A	Landing Width (in)	0.0	N/A	DWS Contrast?	N/A
N/A	Landing Slope (%)	0.0	N/A	DWS Length (in)	N/A
N/A	Landing X Slope (%)	0.0	N/A	DWS Full Width?	N/A
N/A	Landing Curb? (Y/N)	N/A	N/A	DWS Offset LT (in)	N/A
N/A	Shared Landing?	N/A	N/A	DWS Offset RT (in)	N/A
N/A	Gutter Ponding?	0.0	N/A	Gutter Slope (%)	N/A
N/A	Gutter Lip Ht (in)	0.0	N/A	Gutter X Slope (%)	N/A
N/A	Painted X Walk1?	No		Road Slope (%)	3.5
	X Walk 1 Direction	To S		Road X Slope (%)	2.8
	X Walk 1 Width (in)	N/A		Clear Space?	N/A

X Walk 1 Slope (%)	3.5	N/A	Clear Space to XWalk (in)	N/A
	X Walk 1 X Slope (%)	2.8	N/A	Storm Grate/Utility Hazard?	N/A
N/A	Ramp inside XWalk1?	N/A		Storm Grate/Utility Type	
N/A	Any Obstructions?	N/A			N/A
	Obstruction Type		Yes	Surface Condition? (G/P)	Good
			N/A	Curb Slope (%)	3.4

Remove & Replace Entire Ramp.

Total Cost: \$ 1600.00
