# Access Compliance Report

## Public Rights-of-Way

### (Curb Ramps)

Intersection ID: 11108	Main Street: TUCKASEEGEE_RD	Cross Street: N/A	Location: SW
ADA ID: D038C5BA7646	Ramp Type: BlendTrans1	Initial Pass/Fail: Fail	Overall Compliance: No
			Severity Score: 10

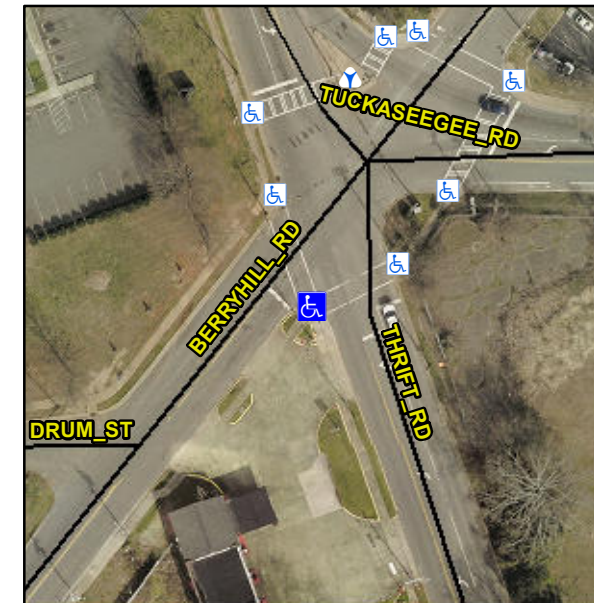
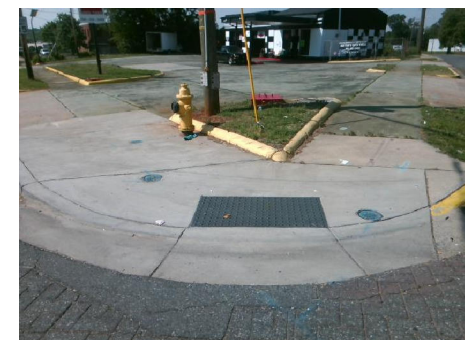
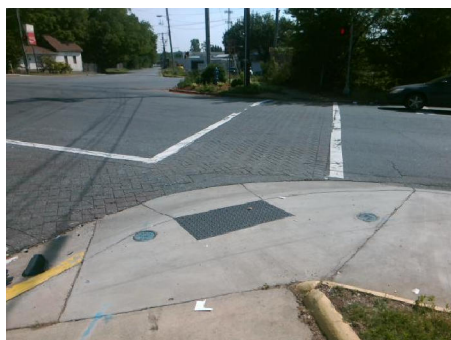
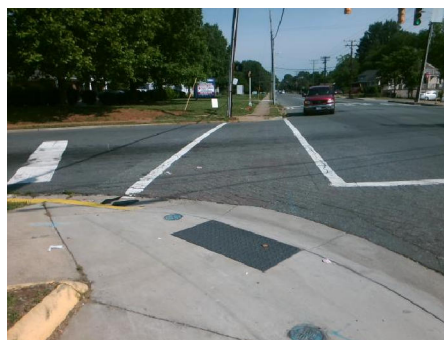
**Not Found, R304.5.1**

Compliance	Description	Data	Compliance	Description	Data
N/A	Ramp Length (in)	61.0	Yes	BlendTrans Slope (%)	3.8
No	Ramp Width (in)	47.5	Yes	BlendTrans XSlope (%)	2.7
N/A	Flare Type LT	N/A	N/A	Flare Type RT	N/A
N/A	Flare Slope LT (%)	N/A	N/A	Flare Slope RT (%)	N/A
N/A	Flare Traversable LT?	N/A	N/A	Flare Traversable RT?	N/A
N/A	Landing Length (in)	N/A	N/A	DWS Provided?	N/A
N/A	Landing Width (in)	N/A	N/A	DWS Contrast?	N/A
N/A	Landing Slope (%)	N/A	N/A	DWS Length (in)	N/A
N/A	Landing X Slope (%)	N/A	N/A	DWS Full Width?	N/A
N/A	Landing Curb? (Y/N)	N/A	N/A	DWS Offset (in)	N/A
N/A	Shared Landing?	N/A			
N/A	Gutter Ponding?	N/A	N/A	Gutter Slope (%)	N/A
N/A	Gutter Lip Ht (in)	N/A	N/A	Gutter X Slope (%)	N/A
N/A	Painted X Walk1?	Yes	N/A	Painted X Walk2?	Yes
	X Walk 1 Direction	To NE		X Walk 2 Direction	To NW
	X Walk 1 Width (in)	111.0		X Walk 2 Width (in)	113.0
	X Walk 1 Slope (%)	1.9		X Walk 2 Slope (%)	4.3
	X Walk 1 X Slope (%)	2.6		X Walk 2 X Slope (%)	2.3

N/A	Ramp inside XWalk1?	Yes	N/A	Ramp inside XWalk2?	Yes
	Road Slope (%)	4.1		Clear Space?	N/A
	Road X Slope (%)	0.9	N/A	Clear Space to XWalk (in)	N/A
N/A	Any Obstructions?	N/A	N/A	Storm Grate/Utility Hazard?	N/A
	Obstruction Type			Storm Grate/Utility Type	
		N/A			N/A
			Yes	Surface Condition? (G/P)	Good
			No	Curb Slope (%)	19.6

**Remove & Replace Curb Ramp With Two New Directional Ramps or Equivalent.**
