## Access Compliance Report Public Rights-of-Way (Curb Ramps)

Intersection ID: 47273	Cross S	ross Street: LIDDINGTON_RD				Location:	NW		
ADA ID: D03B59904ACB Ramp Type: PerpDiag			Initial P	nitial Pass/Fail: Fail Overall Compliance: No				o Severity Score:	22.5
Codes/Mitigation Info/Possible Solution				Field Measurements/Component Compliance					
14245 41		Possible Solutions:		Compliance Description		Data Compliance Description			Data
1 3 A)		Remove & Replace Curb Ramp W	lith	N/A	Ramp Length (in)	47.5	No	Ramp Slope (%)	9.3
2th Address		Two New Directional Ramps or Equivalent.		No	Ramp Width (in)	46.0	No	Ramp XSlope (%)	3.8
				N/A	Flare Type LT	N/A	N/A	Flare Type RT	N/A
	and the second second			N/A	Flare Slope LT (%)	N/A	N/A	Flare Slope RT (%)	N/A
Las Martin				N/A	Flare Traversable LT?	N/A	N/A	Flare Traversable RT?	N/A
				N/A	Landing Length (in)	N/A	N/A	DWS Provided?	N/A
		Surveyor Notes:		N/A	Landing Width (in)	N/A	N/A	DWS Contrast?	N/A
		N/A		N/A	Landing Slope (%)	N/A	N/A	DWS Length (in)	N/A

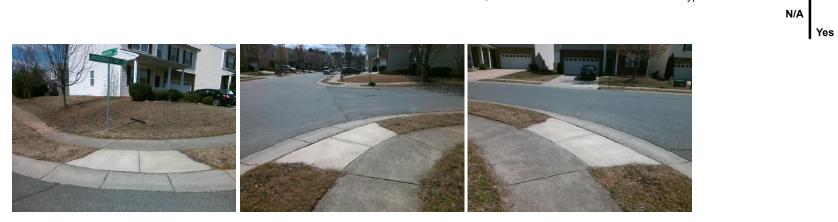
LIDDINGTON_RD		N/A		N/A	Landing X Slope (%)	N/A	N/A	DWS Full Width?	N/A
			N/A	Landing Curb? (Y/N)	N/A	N/A	DWS Offset (in)	N/A	
and the second second second			N/A	Shared Landing?	N/A				
		PROW/ADA:		N/A	Gutter Ponding?	N/A	N/A	Gutter Slope (%)	N/A
	Not Found, R304.5.1, R304.2.2,		N/A	Gutter Lip Ht (in)	N/A	N/A	Gutter X Slope (%)	N/A	
R304.5.3				N/A	Painted X Walk1?	No	N/A	Painted X Walk2?	No
					X Walk 1 Direction	To S		X Walk 2 Direction	To E
				N/A	X Walk 1 Width (in)	N/A	N/A	X Walk 2 Width (in)	N/A
Street 1 Name	LIDDINGTON RD	-			X Walk 1 Slope (%)	0.0		X Walk 2 Slope (%)	2.5
Stop Condition-Street 2	StopSign				X Walk 1 X Slope (%)	1.6		X Walk 2 X Slope (%)	0.1
Street 2 Name	LAMPLIGHTER CLOSE DR			N/A	Ramp inside XWalk1?	N/A	N/A	Ramp inside XWalk2?	N/A
Stop Condition-Street 1	None				Road Slope (%)	4.1	N/A	Clear Space?	N/A
					Road X Slope (%)	0.8	N/A	Clear Space to XWalk (in)	N/A
				N/A	Any Obstructions?	N/A	N/A	Storm Grate/Utility Hazard?	N/A
