Access Compliance Report

Public Rights-of-Way

(Curb Ramps)

| Intersection ID: 5200 | Main Street: MT_HOLLY-HUNTERSVILLE_RD | Cross Street: NORTHWOODS_FOREST_DR | Location: SE |

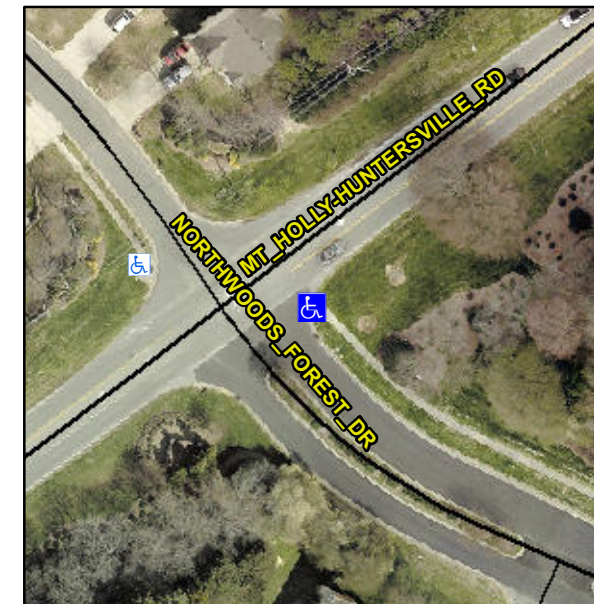
Not Found, R304.5.1, R304.2.2

| Compliance | Description | Data | Compliance | Description | Data |
|---|---|---|---|---|---|
| N/A | Ramp Length (in) | 70.0 | No | Ramp Slope (%) | 9.5 |
| No | Ramp Width (in) | 43.0 | Yes | Ramp XSlope (%) | 4.0 |

Remove & Replace Entire Ramp.
