Access Compliance Report

Public Rights-of-Way

(Curb Ramps)

Intersection ID: 18776	Main Street: SOUTH_BV	Cross Street: TYVOLA_RD	Location: SE
ADA ID: D048C40D2820	Ramp Type: PerpDiag	Initial Pass/Fail: Fail	Overall Compliance: No
			Severity Score: 21.25

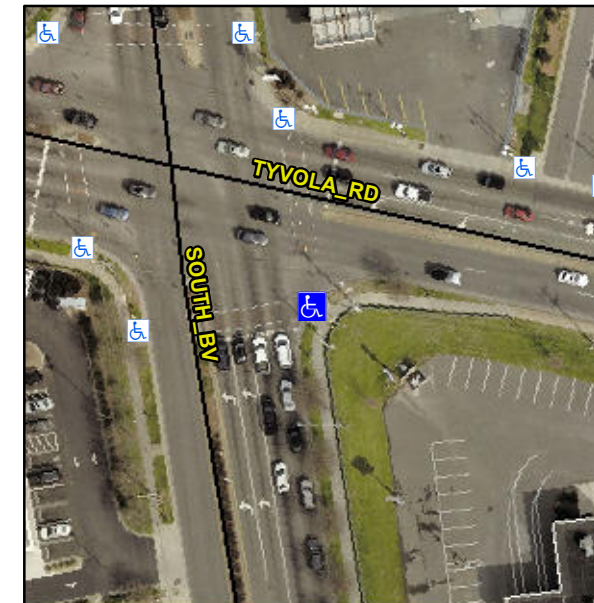
Compliance	Description	Data	Compliance	Description	Data
N/A	Ramp Length (in)	73.0	Yes	Ramp Slope (%)	6.8
No	Ramp Width (in)	47.0	No	Ramp XSlope (%)	5.2
N/A	Flare Type LT	N/A	N/A	Flare Type RT	N/A
N/A	Flare Slope LT (%)	N/A	N/A	Flare Slope RT (%)	N/A
N/A	Flare Traversable LT?	N/A	N/A	Flare Traversable RT?	N/A
N/A	Landing Length (in)	N/A	N/A	DWS Provided?	N/A
N/A	Landing Width (in)	N/A	N/A	DWS Contrast?	N/A
N/A	Landing Slope (%)	N/A	N/A	DWS Length (in)	N/A
N/A	Landing X Slope (%)	N/A	N/A	DWS Full Width?	N/A
N/A	Landing Curb? (Y/N)	N/A	N/A	DWS Offset (in)	N/A
N/A	Shared Landing?	N/A			
N/A	Gutter Ponding?	N/A	N/A	Gutter Slope (%)	N/A
N/A	Gutter Lip Ht (in)	N/A	N/A	Gutter X Slope (%)	N/A
N/A	Painted X Walk1?	Yes	N/A	Painted X Walk2?	Yes
	X Walk 1 Direction	To N		X Walk 2 Direction	To W
N/A	X Walk 1 Width (in)	118.0	N/A	X Walk 2 Width (in)	112.0
	X Walk 1 Slope (%)	5.4		X Walk 2 Slope (%)	4.8
	X Walk 1 X Slope (%)	7.5		X Walk 2 X Slope (%)	0.7

N/A	Ramp inside XWalk1?	Yes	N/A	Ramp inside XWalk2?	Yes
	Road Slope (%)	4.5	N/A	Clear Space?	N/A
	Road X Slope (%)	5.5	N/A	Clear Space to XWalk (in)	N/A
N/A	Any Obstructions?	N/A	N/A	Storm Grate/Utility Hazard?	N/A
	Obstruction Type			Storm Grate/Utility Type	
		N/A			N/A
		Yes		Surface Condition? (G/P)	Good

Possible Solutions:

Remove & Replace Curb Ramp With Two New Directional Ramps or Equivalent.

R304.5.1, R304.5.3
