Access Compliance Report

Public Rights-of-Way

(Curb Ramps)

Intersection ID: 10025976		Main Street: ELM_LN		Cross Street: N/A		Location:		NW	
ADA ID: D04C089E0CA3		Ramp Type: Directional1		Initial Pass/Fail: Fail		Overall Compliance: No		Severity Score: 1.25	
Codes/Mitigation Info/Possible Solution				Field Measurements/Component Compliance					
<div>

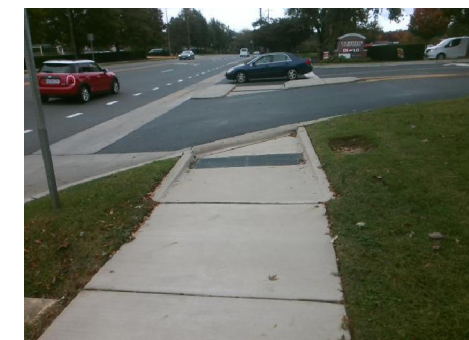
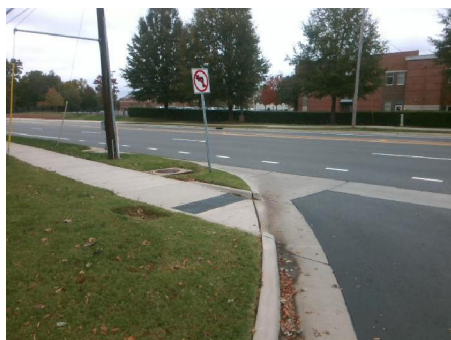
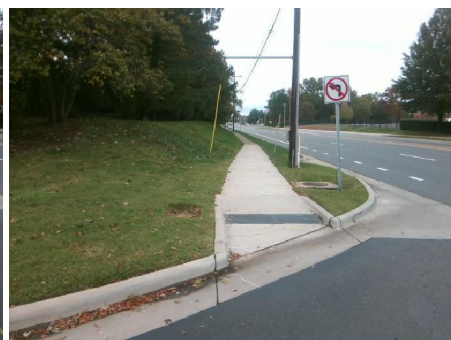
N/A	Flare Traversable LT?	N/A	N/A	Flare Traversable RT?	N/A
				N/A	Landing Length (in)	0.0	N/A	DWS Provided?	N/A
				N/A	Landing Width (in)	0.0	N/A	DWS Contrast?	N/A
				N/A	Landing Slope (%)	0.0	N/A	DWS Length (in)	N/A
				N/A	Landing X Slope (%)	0.0	N/A	DWS Full Width?	N/A
				N/A	Landing Curb? (Y/N)	N/A	N/A	DWS Offset LT (in)	N/A
				N/A	Shared Landing?	N/A	N/A	DWS Offset RT (in)	N/A
				N/A	Gutter Ponding?	0.0	N/A	Gutter Slope (%)	N/A
				N/A	Gutter Lip Ht (in)	0.0	N/A	Gutter X Slope (%)	N/A
				N/A	Painted X Walk1?	No		Road Slope (%)	1.5
					X Walk 1 Direction	To S		Road X Slope (%)	3.0
					X Walk 1 Width (in)	N/A		Clear Space?	N/A
					X Walk 1 Slope (%)	1.5	N/A	Clear Space to XWalk (in)	N/A
					X Walk 1 X Slope (%)	3.0	N/A	Storm Grate/Utility Hazard?	N/A
				N/A	Ramp inside XWalk1?	N/A		Storm Grate/Utility Type	
				N/A	Any Obstructions?	N/A			N/A
					Obstruction Type		Yes	Surface Condition? (G/P)	Good

N/A	Curb Slope (%)	3.9
