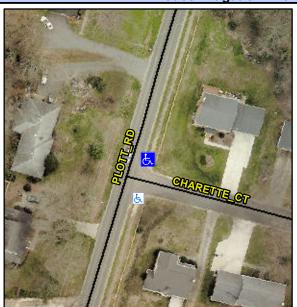
Intersection ID: 11977Main Street: CHARETTE_CTCross Street: PLOTT_RDLocation:NEADA ID: D054177EF1BCRamp Type: PerpInitial Pass/Fail: FailOverall Compliance: NoSeverity Score: 8.75

| 71 CSSIDIC COIGITOTI | |
|---|---|
| Not Found, R304.5.1 | N. |

| Field Measurements/Component Compliance | | | | | | |
|---|---|---|---|---|---|--|
| No | Ramp Width (in) | 44.0 | Yes | Ramp XSlope (%) | 1.7 | |

| 71 CSSIDIC COIGITOTI | |
|---|---|
| Remove & Replace Entire Ramp. | N |
