Access Compliance Report Public Rights-of-Way (Curb Ramps)

Intersection ID: 10028595 Main Street: HONEY_CREEK_LN Cross Street: N/A Location: S

ADA ID: D05790CCEDEA Ramp Type: Perp Initial Pass/Fail: Fail Overall Compliance: No Severity Score: 12.5

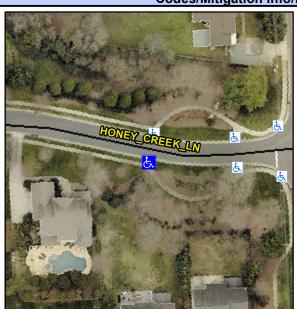
Field Measurements/Component Compilance									
Compliance Description			Comp	liance Description	Data				
N/A	Ramp Length (in)	51.0	No	Ramp Slope (%)	10.6				
Yes	Ramp Width (in)	72.0	Yes	Ramp XSlope (%)	0.1				
N/A	Flare Type LT	N/A	N/A	Flare Type RT	N/A				
N/A	Flare Slope LT (%)	N/A	N/A	Flare Slope RT (%)	N/A				
N/A	Flare Traversable LT?	N/A	N/A	Flare Traversable RT?	N/A				
N/A	Landing Length (in)	N/A	N/A	DWS Provided?	N/A				
N/A	Landing Width (in)	N/A	N/A	DWS Contrast?	N/A				
N/A	Landing Slope (%)	N/A	N/A	DWS Length (in)	N/A				
N/A	Landing X Slope (%)	N/A	N/A	DWS Full Width?	N/A				
N/A	Landing Curb? (Y/N)	N/A	N/A	DWS Offset (in)	N/A				
N/A	Shared Landing?	N/A							
N/A	Gutter Ponding?	N/A	N/A	Gutter Slope (%)	N/A				
N/A	Gutter Lip Ht (in)	N/A	N/A	Gutter X Slope (%)	N/A				
N/A	Painted X Walk1?	No	N/A	Painted X Walk2?	N/A				
	X Walk 1 Direction	To N		X Walk 2 Direction	N/A				
N/A	X Walk 1 Width (in)	N/A	N/A	X Walk 2 Width (in)	N/A

X Walk 1 Slope (%)	3.6		X Walk 2 Slope (%)	N/A				
	X Walk 1 X Slope (%)	0.9		X Walk 2 X Slope (%)	N/A				
N/A	Ramp inside XWalk1?	N/A	N/A	Ramp inside XWalk2?	N/A				
	Road Slope (%)	N/A	N/A	Clear Space?	N/A				
	Road X Slope (%)	N/A	N/A	Clear Space to XWalk (in)	N/A				
N/A	Any Obstructions?	N/A	N/A	Storm Grate/Utility Hazard?	N/A				
	Obstruction Type			Storm Grate/Utility Type					
		N/A			N/A				
			Yes	Surface Condition? (G/P)	Good

Remove & Replace Entire Ramp. No.	1 Coolbio Colation	
Surveyor Notes: N/A PROW/ADA: Not Found, R304.2.2	Possible Solutions:	Con
Surveyor Notes: N/A PROW/ADA: Not Found, R304.2.2	Remove & Replace Entire Ramp.	N/A
Surveyor Notes: N/A PROW/ADA: Not Found, R304.2.2	•	Yes
Surveyor Notes: N/A N/A PROW/ADA: Not Found, R304.2.2		N/A
Surveyor Notes: N/A N/A PROW/ADA: Not Found, R304.2.2		N/A
Surveyor Notes: N/A N/A PROW/ADA: Not Found, R304.2.2		N/A
N/A N/A N N N PROW/ADA: Not Found, R304.2.2		N/A
PROW/ADA: Not Found, R304.2.2	Surveyor Notes:	N/A
PROW/ADA: Not Found, R304.2.2	N/A	N/A
PROW/ADA: Not Found, R304.2.2		N/A
PROW/ADA: Not Found, R304.2.2 N		N/A
Not Found, R304.2.2		N/A
Not i ound, 1004.2.2	PROW/ADA:	N/A
N	Not Found, R304.2.2	N/A
N		N/A
		N/A
N		N/A

1850.00
