Access Compliance Report

Public Rights-of-Way

(Curb Ramps)

Intersection ID: 17621	Main Street: CROYDON_RD	Cross Street: RIDGEWOOD_AV	Location: NW
ADA ID: D05A2516CE9B	Ramp Type: Perp	Initial Pass/Fail: Fail	Overall Compliance: No
		Severity Score: 25

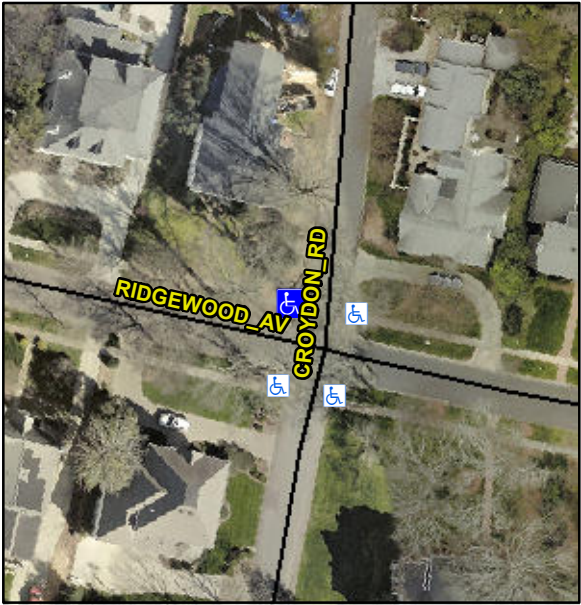
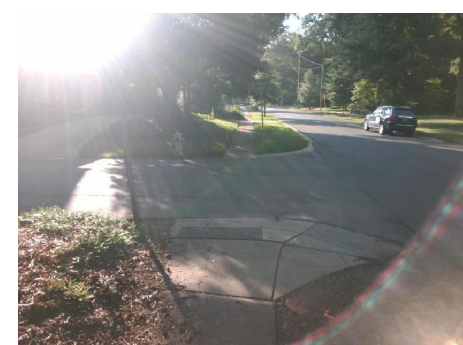
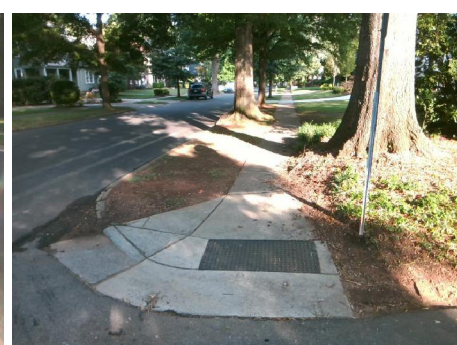
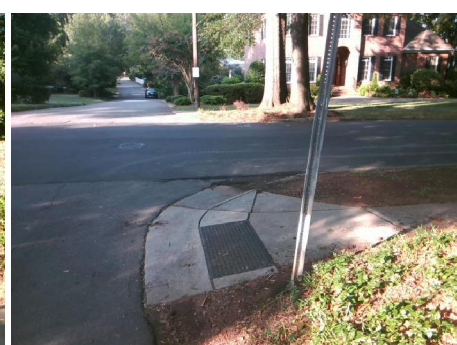
Possible Solutions:		Compliance	Description	Data
	Remove & Replace Entire Ramp.		Yes	Ramp Length (in)	25.0
			N/A	Ramp Width (in)	48.0
			N/A	Flare Type LT	N/A
			N/A	Flare Slope LT (%)	N/A
			N/A	Flare Traversable LT?	N/A
			N/A	Flare Type RT	N/A
			N/A	Flare Slope RT (%)	N/A
			N/A	Flare Traversable RT?	N/A
			N/A	DWS Provided?	N/A
<p>Surveyor Notes:</p> <p>N/A</p>			N/A	DWS Contrast?	N/A
			N/A	DWS Length (in)	N/A
			N/A	DWS Full Width?	N/A
			N/A	DWS Offset (in)	N/A
			N/A	Shared Landing?	N/A
			N/A	Gutter Ponding?	N/A
			N/A	Gutter Lip Ht (in)	N/A
			N/A	Painted X Walk1?	No
			N/A	X Walk 1 Direction	To SE
			N/A	X Walk 1 Width (in)	N/A
<p>PROW/ADA:</p> <p>Not Found, R304.5.3</p>			N/A	X Walk 1 Slope (%)	4.7
			N/A	X Walk 1 X Slope (%)	2.7
			N/A	Ramp inside XWalk1?	N/A
			N/A	Ramp inside XWalk2?	N/A
			N/A	Road Slope (%)	N/A

N/A	Road X Slope (%)	N/A
			N/A	Clear Space?	N/A
			N/A	Clear Space to XWalk (in)	N/A
			N/A	Storm Grate/Utility Hazard?	N/A
			N/A	Storm Grate/Utility Type	N/A
<p>Total Cost:</p> <p>\$ 1850.00</p>			N/A	Obstruction Type	N/A
			Yes	Surface Condition? (G/P)	Good
