Access Compliance Report Public Rights-of-Way (Curb Ramps)

Intersection ID: 14746	Main Street: ALBEMARLE_RD			treet:	WILGROVE-MINT_HILI	Location:	SW		
ADA ID: D0605E863374	3374 Ramp Type: Perp			Initial Pass/Fail: Fail Overall Compliance: No				Severity Score:	12.5
Codes/Mitigation Info/Possible Solution			Field Measurements/Component Compliance

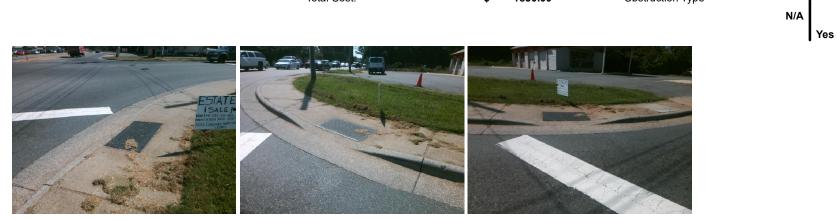
*	10 400 M	Possible Solutions:	Compliance Description			Data	Data Compliance Description		
A BEE BEECK	Co alle	Remove & Replace Entire Ramp		N/A	Ramp Length (in)	55.0	No	Ramp Slope (%)	8.4
A State of the second s				Yes	Ramp Width (in)	48.0	Yes	Ramp XSlope (%)	1.9
