# Access Compliance Report

## Public Rights-of-Way

### (Curb Ramps)

| Intersection ID: 17241 | Main Street: S_CANTERBURY_RD | Cross Street: S_WENDOVER_RD | Location: NE |

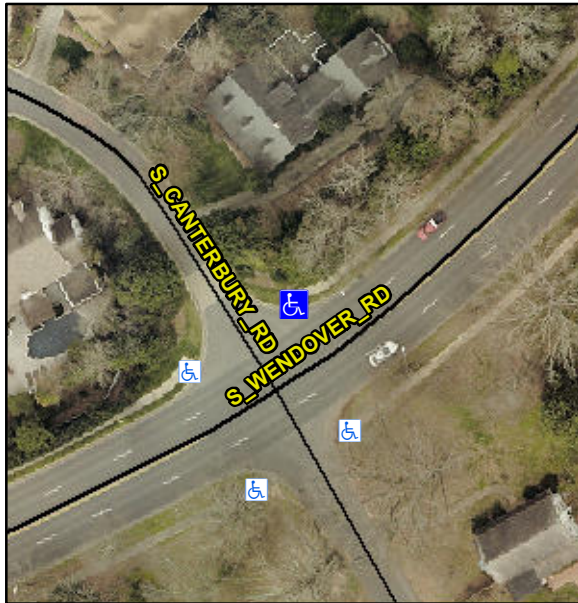
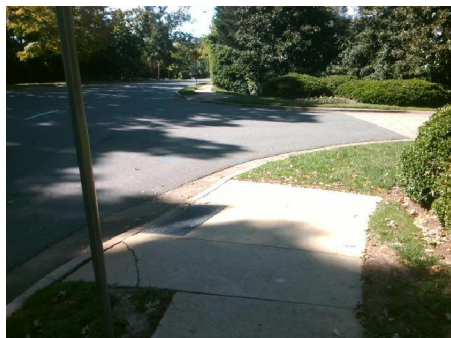
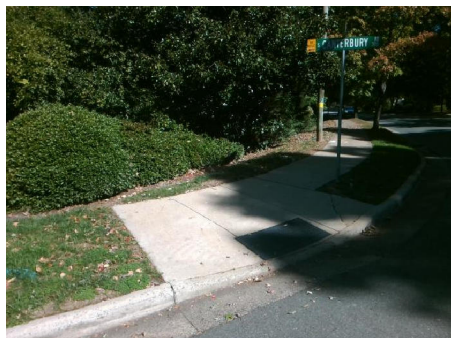
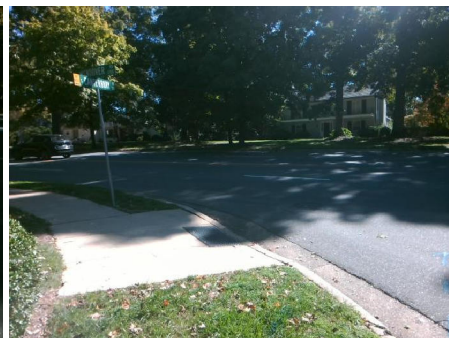
| ADA ID: D06BDB142C43 | Ramp Type: PerpDiag | Initial Pass/Fail: Fail | Overall Compliance: No |

**R304.5.1, R304.2.2, R304.5.3**

| Compliance | Description | Data | Compliance | Description | Data |
|---|---|---|---|---|---|
| N/A | Ramp Length (in) | 109.0 | No | Ramp Slope (%) | 14.4 |
| No | Ramp Width (in) | 44.0 | No | Ramp XSlope (%) | 7.4 |

**Remove & Replace Curb Ramp With Two New Directional Ramps or Equivalent.**
