Access Compliance Report Public Rights-of-Way (Curb Ramps)

Intersection ID: 31934 Main Street: STEELE_CREEK_RD Cross Street: BRANCH_BEND_LN Location: W

ADA ID: D07C3D75CFAF Ramp Type: BlendTrans2 Initial Pass/Fail: Fail Overall Compliance: No Severity Score: 12.5

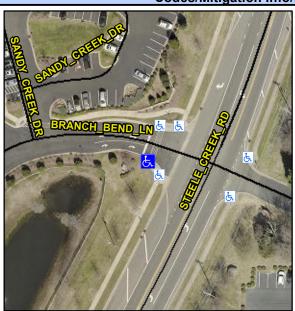
Compliance Description		Data	Comp	liance Description	Data
N/A	Ramp Length (in)	85.0	Yes	BlendTrans Slope (%)	0.8
Yes	Ramp Width (in)	60.0	No	BlendTrans XSlope (%)	6.2
N/A	Flare Type LT	N/A	N/A	Flare Type RT	N/A
N/A	Flare Slope LT (%)	N/A	N/A	Flare Slope RT (%)	N/A
N/A	Flare Traversable LT?	N/A	N/A	Flare Traversable RT?	N/A
N/A	Landing Length (in)	N/A	N/A	DWS Provided?	N/A
N/A	Landing Width (in)	N/A	N/A	DWS Contrast?	N/A
N/A	Landing Slope (%)	N/A	N/A	DWS Length (in)	N/A
N/A	Landing X Slope (%)	N/A	N/A	DWS Full Width?	N/A
N/A	Landing Curb? (Y/N)	N/A	N/A	DWS Offset (in)	N/A
N/A	Shared Landing?	N/A			
N/A	Gutter Ponding?	N/A	N/A	Gutter Slope (%)	N/A
N/A	Gutter Lip Ht (in)	N/A	N/A	Gutter X Slope (%)	N/A
N/A	Painted X Walk1?	Yes	N/A	Painted X Walk2?	N/A
	X Walk 1 Direction	To N		X Walk 2 Direction	N/A
	X Walk 1 Width (in)	61.0		X Walk 2 Width (in)	N/A
	X Walk 1 Slope (%)	2.3		X Walk 2 Slope (%)	N/A
	X Walk 1 X Slope (%)	2.7		X Walk 2 X Slope (%)	N/A

N/A	Ramp inside XWalk1?	Yes	N/A	Ramp inside XWalk2?	N/A
	Road Slope (%)	2.7		Clear Space?	N/A
	Road X Slope (%)	2.3	N/A	Clear Space to XWalk (in)	N/A
N/A	Any Obstructions?	N/A	N/A	Storm Grate/Utility Hazard?	N/A
	Obstruction Type			Storm Grate/Utility Type	
		N/A			N/A
			Yes	Surface Condition? (G/P)	Good
CTOP			N/A	Curb Slope (%)	0.7

Remove & Replace Curb Ramp With Two New Directional Ramps or Equivalent.
