# Access Compliance Report

## Public Rights-of-Way

### (Curb Ramps)

| Intersection ID: 22096 | Main Street: COLONY_RD | Cross Street: CARMEL_CRESCENT_DR | Location: NE |

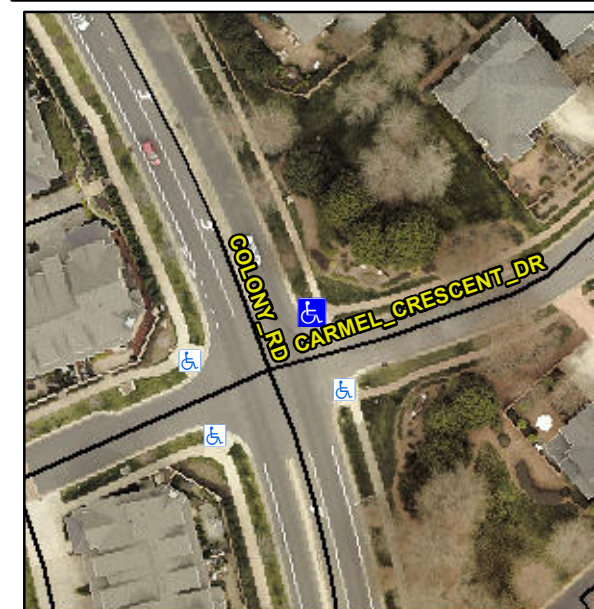
**Not Found, R304.2.2, R304.5.3**

| Compliance | Description | Data | Compliance | Description | Data |
|---|---|---|---|---|---|
| N/A | Ramp Length (in) | 97.0 | No | Ramp Slope (%) | 8.4 |
| Yes | Ramp Width (in) | 52.0 | No | Ramp XSlope (%) | 2.6 |

**Remove & Replace Curb Ramp With Two New Directional Ramps or Equivalent.**

Total Cost: \$ 3200.00

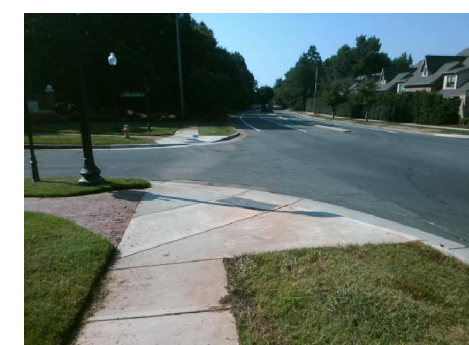
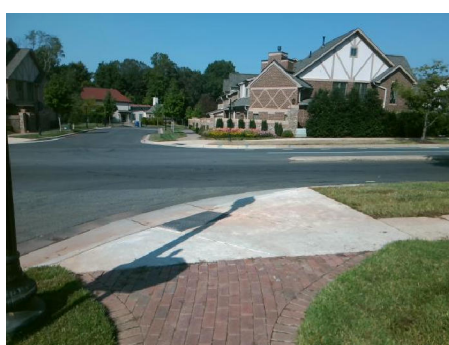
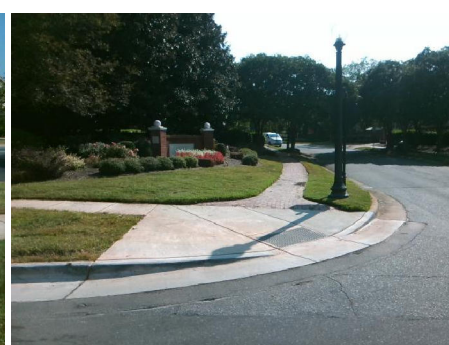
| Compliance | Description | Data | Compliance | Description | Data |
|---|---|---|---|---|---|
| | | | Yes | Surface Condition? (G/P) | Good |
