Access Compliance Report

Public Rights-of-Way

(Curb Ramps)

Intersection ID: 10023268	Main Street: CHELTON RIDGE LN	Cross Street: N/A	Location: NE
ADA ID: D09F0C686EEB	Ramp Type: PerpDiag	Initial Pass/Fail: Fail	Overall Compliance: No
Severity Score: 25			
Codes/Mitigation Info/Possible Solution		Field Measurements/Component Compliance

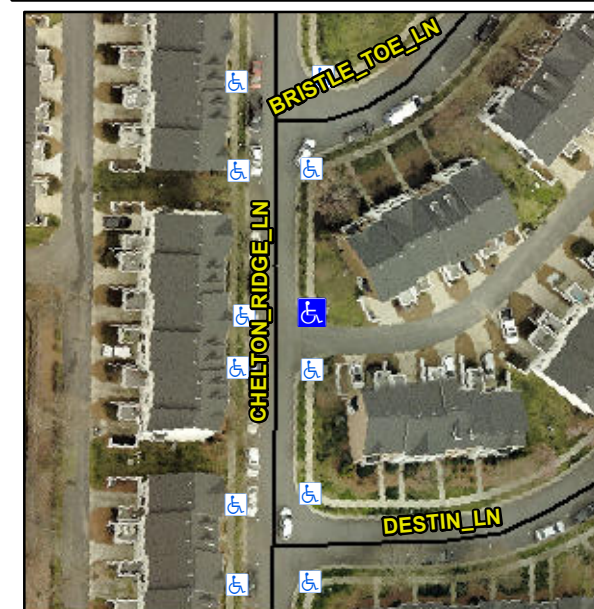
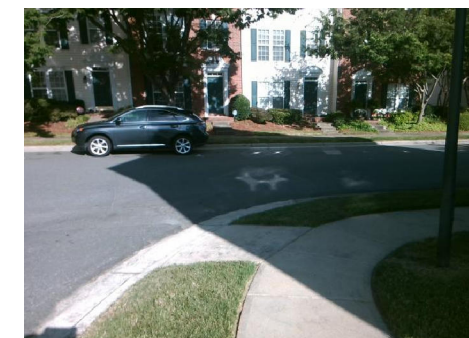
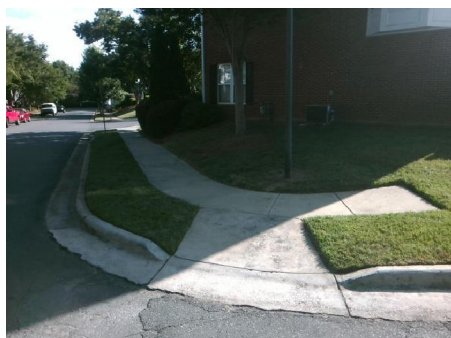
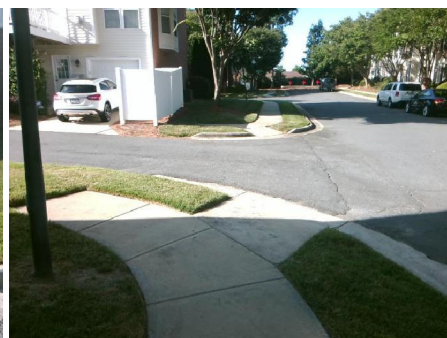
Not Found, R304.2.2, R304.5.3

Compliance	Description	Data	Compliance	Description	Data
N/A	Ramp Length (in)	50.0	No	Ramp Slope (%)	9.9
Yes	Ramp Width (in)	60.0	No	Ramp XSlope (%)	5.1
N/A	Flare Type LT	N/A	N/A	Flare Type RT	N/A
N/A	Flare Slope LT (%)	N/A	N/A	Flare Slope RT (%)	N/A
N/A	Flare Traversable LT?	N/A	N/A	Flare Traversable RT?	N/A
N/A	Landing Length (in)	N/A	N/A	DWS Provided?	N/A
N/A	Landing Width (in)	N/A	N/A	DWS Contrast?	N/A
N/A	Landing Slope (%)	N/A	N/A	DWS Length (in)	N/A
N/A	Landing X Slope (%)	N/A	N/A	DWS Full Width?	N/A
N/A	Landing Curb? (Y/N)	N/A	N/A	DWS Offset (in)	N/A
N/A	Shared Landing?	N/A			
N/A	Gutter Ponding?	N/A	N/A	Gutter Slope (%)	N/A
N/A	Gutter Lip Ht (in)	1.0	N/A	Gutter X Slope (%)	N/A
N/A	Painted X Walk1?	No	N/A	Painted X Walk2?	No
	X Walk 1 Direction	To NW		X Walk 2 Direction	To S
N/A	X Walk 1 Width (in)	N/A	N/A	X Walk 2 Width (in)	N/A
	X Walk 1 Slope (%)	1.4		X Walk 2 Slope (%)	3.0
	X Walk 1 X Slope (%)	1.4		X Walk 2 X Slope (%)	3.7

N/A	Ramp inside XWalk1?	N/A	N/A	Ramp inside XWalk2?	N/A
	Road Slope (%)	5.1	N/A	Clear Space?	N/A
	Road X Slope (%)	2.6	N/A	Clear Space to XWalk (in)	N/A
N/A	Any Obstructions?	N/A	N/A	Storm Grate/Utility Hazard?	N/A
	Obstruction Type			Storm Grate/Utility Type	
		N/A			N/A
		Yes		Surface Condition? (G/P)	Good

Remove & Replace Curb Ramp With Two New Directional Ramps or Equivalent.
