# Access Compliance Report

## Public Rights-of-Way

### (Curb Ramps)

| Intersection ID: 11931 | Main Street: E_17TH_ST | Cross Street: HARRILL_ST | Location: SE |

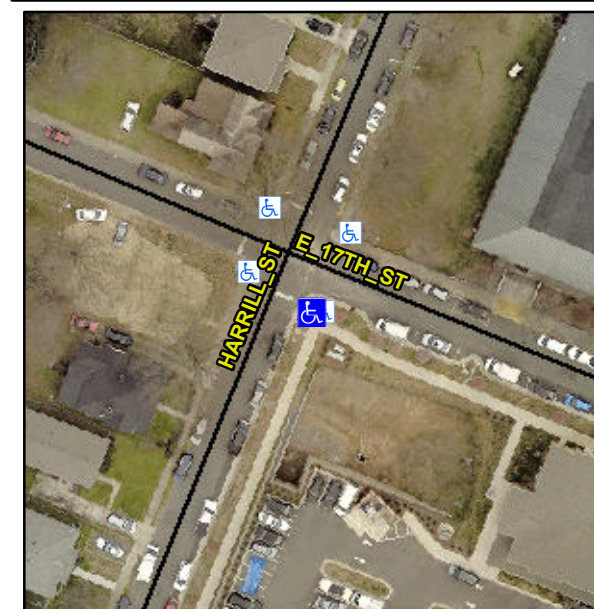
**Not Found, R304.2.2, R304.5.3**

| Compliance | Description | Data | Compliance | Description | Data |
|---|---|---|---|---|---|
| N/A | Ramp Length (in) | 96.0 | No | Ramp Slope (%) | 12.8 |
| Yes | Ramp Width (in) | 58.0 | No | Ramp XSlope (%) | 2.9 |

**Remove & Replace Entire Ramp.**

Total Cost: \$ 1850.00
