# Access Compliance Report

## Public Rights-of-Way

### (Curb Ramps)

Intersection ID: 44172	Main Street: SOUTHBROOK_DR	Cross Street: BELLEGARDE_DR	Location: SE
ADA ID: D0B2F8F4E1D4	Ramp Type: PerpDiag	Initial Pass/Fail: Fail	Overall Compliance: No
Severity Score: 21.25			
Codes/Mitigation Info/Possible Solution		Field Measurements/Component Compliance

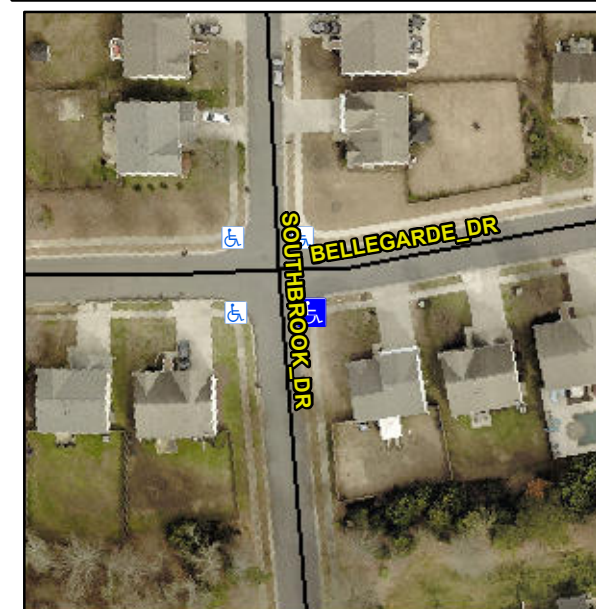
**Not Found, R304.5.1, R304.5.3**

Compliance	Description	Data	Compliance	Description	Data
N/A	Ramp Length (in)	46.0	Yes	Ramp Slope (%)	5.5
No	Ramp Width (in)	36.0	No	Ramp XSlope (%)	5.2
N/A	Flare Type LT	N/A	N/A	Flare Type RT	N/A
N/A	Flare Slope LT (%)	N/A	N/A	Flare Slope RT (%)	N/A
N/A	Flare Traversable LT?	N/A	N/A	Flare Traversable RT?	N/A
N/A	Landing Length (in)	N/A	N/A	DWS Provided?	N/A
N/A	Landing Width (in)	N/A	N/A	DWS Contrast?	N/A
N/A	Landing Slope (%)	N/A	N/A	DWS Length (in)	N/A
N/A	Landing X Slope (%)	N/A	N/A	DWS Full Width?	N/A
N/A	Landing Curb? (Y/N)	N/A	N/A	DWS Offset (in)	N/A
N/A	Shared Landing?	N/A			
N/A	Gutter Ponding?	N/A	N/A	Gutter Slope (%)	N/A
N/A	Gutter Lip Ht (in)	1.5	N/A	Gutter X Slope (%)	N/A
N/A	Painted X Walk1?	No	N/A	Painted X Walk2?	No
	X Walk 1 Direction	To N		X Walk 2 Direction	To W
N/A	X Walk 1 Width (in)	N/A	N/A	X Walk 2 Width (in)	N/A
	X Walk 1 Slope (%)	3.4		X Walk 2 Slope (%)	2.7
	X Walk 1 X Slope (%)	2.7		X Walk 2 X Slope (%)	0.6

N/A	Ramp inside XWalk1?	N/A	N/A	Ramp inside XWalk2?	N/A
	Road Slope (%)	1.8	N/A	Clear Space?	N/A
	Road X Slope (%)	5.8	N/A	Clear Space to XWalk (in)	N/A
N/A	Any Obstructions?	N/A	N/A	Storm Grate/Utility Hazard?	N/A
	Obstruction Type			Storm Grate/Utility Type	
		N/A			N/A
		Yes		Surface Condition? (G/P)	Good

**Remove & Replace Curb Ramp With Two New Directional Ramps or Equivalent.**
