Access Compliance Report

Public Rights-of-Way

(Curb Ramps)

Intersection ID: 9553	Main Street: BEATTIES_FORD_RD	Cross Street: PATTON_AV	Location: SE
ADA ID: D0E476558B22	Ramp Type: PerpDiag	Initial Pass/Fail: Fail	Overall Compliance: No
Codes/Mitigation Info/Possible Solution		Field Measurements/Component Compliance

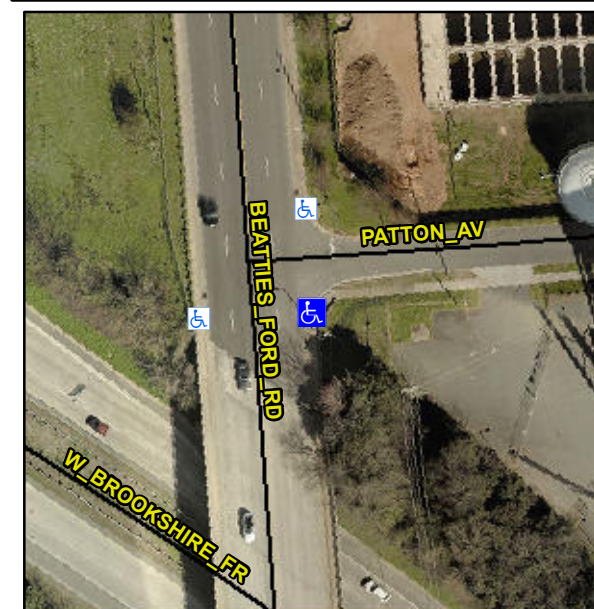
R304.2.2, R304.5.3

Compliance	Description	Data	Compliance	Description	Data
N/A	Ramp Length (in)	57.5	No	Ramp Slope (%)	11.1
Yes	Ramp Width (in)	54.5	No	Ramp XSlope (%)	3.5
N/A	Flare Type LT	N/A	N/A	Flare Type RT	N/A
N/A	Flare Slope LT (%)	N/A	N/A	Flare Slope RT (%)	N/A
N/A	Flare Traversable LT?	N/A	N/A	Flare Traversable RT?	N/A
N/A	Landing Length (in)	N/A	N/A	DWS Provided?	N/A
N/A	Landing Width (in)	N/A	N/A	DWS Contrast?	N/A
N/A	Landing Slope (%)	N/A	N/A	DWS Length (in)	N/A
N/A	Landing X Slope (%)	N/A	N/A	DWS Full Width?	N/A
N/A	Landing Curb? (Y/N)	N/A	N/A	DWS Offset (in)	N/A
N/A	Shared Landing?	N/A			
N/A	Gutter Ponding?	N/A	N/A	Gutter Slope (%)	N/A
N/A	Gutter Lip Ht (in)	N/A	N/A	Gutter X Slope (%)	N/A
N/A	Painted X Walk1?	No	N/A	Painted X Walk2?	No
	X Walk 1 Direction	To N		X Walk 2 Direction	To W
N/A	X Walk 1 Width (in)	N/A	N/A	X Walk 2 Width (in)	N/A
	X Walk 1 Slope (%)	2.7		X Walk 2 Slope (%)	2.6
	X Walk 1 X Slope (%)	2.3		X Walk 2 X Slope (%)	1.2

N/A	Ramp inside XWalk1?	N/A	N/A	Ramp inside XWalk2?	N/A
	Road Slope (%)	2.6	N/A	Clear Space?	N/A
	Road X Slope (%)	1.9	N/A	Clear Space to XWalk (in)	N/A
N/A	Any Obstructions?	N/A	N/A	Storm Grate/Utility Hazard?	N/A
	Obstruction Type			Storm Grate/Utility Type	
		N/A			N/A
			Yes	Surface Condition? (G/P)	Good

Remove & Replace Curb Ramp With Two New Directional Ramps or Equivalent.
