Access Compliance Report

Public Rights-of-Way

(Curb Ramps)

Intersection ID: 14612		Main Street: BAXTER_ST		Cross Street: MAIN_ST		Location: SE			
ADA ID: D0F36EBDCCA8		Ramp Type: PerpDiag		Initial Pass/Fail: Fail		Overall Compliance: No		Severity Score: 60	
Codes/Mitigation Info/Possible Solution					Field Measurements/Component Compliance

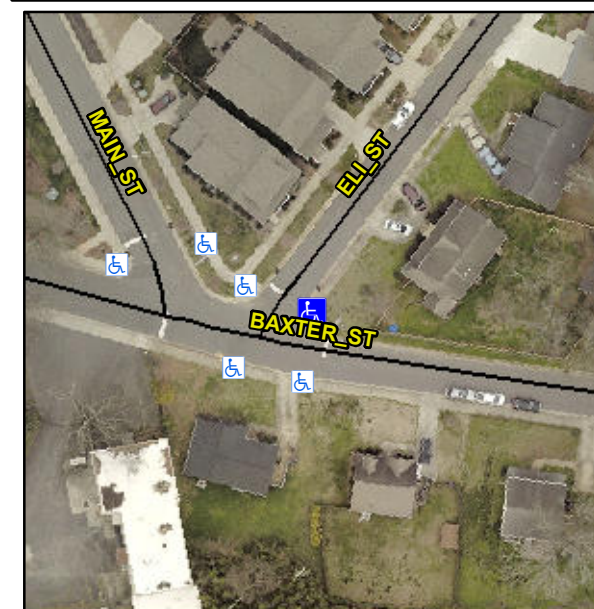
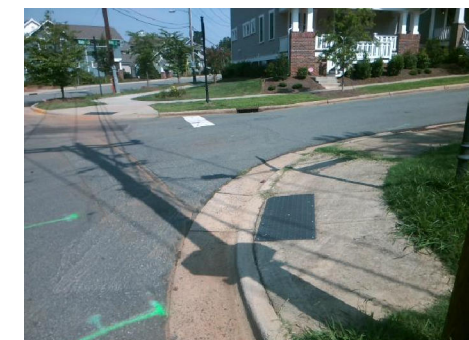
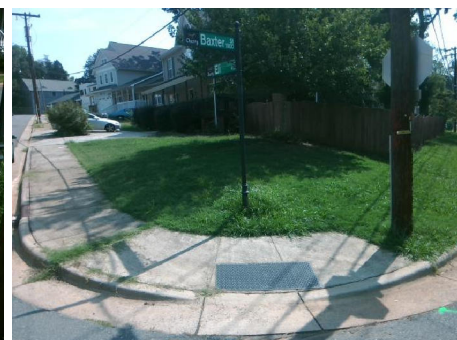
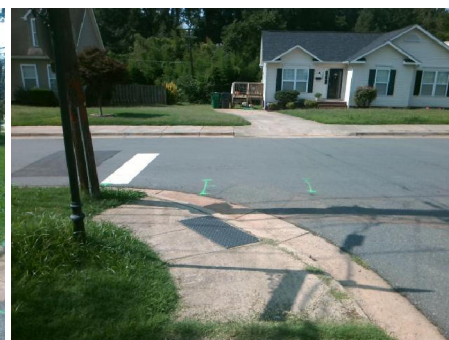
Not Found, R304.5.1, R304.2.2, R304.5.3

Compliance	Description	Data	Compliance	Description	Data
N/A	Ramp Length (in)	60.0	No	Ramp Slope (%)	11.4
No	Ramp Width (in)	29.0	No	Ramp XSlope (%)	5.5
N/A	Flare Type LT	N/A	N/A	Flare Type RT	N/A
N/A	Flare Slope LT (%)	N/A	N/A	Flare Slope RT (%)	N/A
N/A	Flare Traversable LT?	N/A	N/A	Flare Traversable RT?	N/A
N/A	Landing Length (in)	N/A	N/A	DWS Provided?	N/A
N/A	Landing Width (in)	N/A	N/A	DWS Contrast?	N/A
N/A	Landing Slope (%)	N/A	N/A	DWS Length (in)	N/A
N/A	Landing X Slope (%)	N/A	N/A	DWS Full Width?	N/A
N/A	Landing Curb? (Y/N)	N/A	N/A	DWS Offset (in)	N/A
N/A	Shared Landing?	N/A			
N/A	Gutter Ponding?	N/A	N/A	Gutter Slope (%)	N/A
N/A	Gutter Lip Ht (in)	N/A	N/A	Gutter X Slope (%)	N/A
N/A	Painted X Walk1?	No	N/A	Painted X Walk2?	No
	X Walk 1 Direction	To NW		X Walk 2 Direction	To SW
N/A	X Walk 1 Width (in)	N/A	N/A	X Walk 2 Width (in)	N/A
	X Walk 1 Slope (%)	2.7		X Walk 2 Slope (%)	1.8
	X Walk 1 X Slope (%)	7.6		X Walk 2 X Slope (%)	1.1

N/A	Ramp inside XWalk1?	N/A	N/A	Ramp inside XWalk2?	N/A
	Road Slope (%)	3.2	N/A	Clear Space?	N/A
	Road X Slope (%)	5.8	N/A	Clear Space to XWalk (in)	N/A
N/A	Any Obstructions?	N/A	N/A	Storm Grate/Utility Hazard?	N/A
	Obstruction Type			Storm Grate/Utility Type	
		N/A			N/A
		Yes		Surface Condition? (G/P)	Good

Remove & Replace Curb Ramp With Two New Directional Ramps or Equivalent.
