Access Compliance Report

Public Rights-of-Way (Curb Ramps)

Intersection ID: 48283	Main Street: MEADOWMONT_VIEW_DR	Cross Street: MEADOWMONT_VIEW_DR	Location: NW
ADA ID: D0F6CDFD87B1	Ramp Type: Perp	Initial Pass/Fail: Fail	Overall Compliance: No
Severity Score: 12.5			
Codes/Mitigation Info/Possible Solution		Field Measurements/Component Compliance

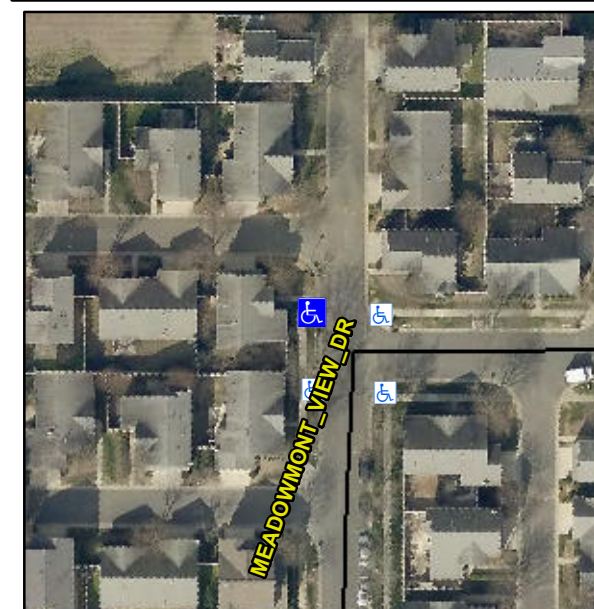
Not Found, R304.2.2

Compliance	Description	Data	Compliance	Description	Data
N/A	Ramp Length (in)	70.0	No	Ramp Slope (%)	11.3
Yes	Ramp Width (in)	48.0	Yes	Ramp XSlope (%)	0.8
N/A	Flare Type LT	N/A	N/A	Flare Type RT	N/A
N/A	Flare Slope LT (%)	N/A	N/A	Flare Slope RT (%)	N/A
N/A	Flare Traversable LT?	N/A	N/A	Flare Traversable RT?	N/A
N/A	Landing Length (in)	N/A	N/A	DWS Provided?	N/A
N/A	Landing Width (in)	N/A	N/A	DWS Contrast?	N/A
N/A	Landing Slope (%)	N/A	N/A	DWS Length (in)	N/A
N/A	Landing X Slope (%)	N/A	N/A	DWS Full Width?	N/A
N/A	Landing Curb? (Y/N)	N/A	N/A	DWS Offset (in)	N/A
N/A	Shared Landing?	N/A			
N/A	Gutter Ponding?	N/A	N/A	Gutter Slope (%)	N/A
N/A	Gutter Lip Ht (in)	N/A	N/A	Gutter X Slope (%)	N/A
N/A	Painted X Walk1?	No	N/A	Painted X Walk2?	N/A
	X Walk 1 Direction	To E		X Walk 2 Direction	N/A
N/A	X Walk 1 Width (in)	N/A	N/A	X Walk 2 Width (in)	N/A
	X Walk 1 Slope (%)	0.5		X Walk 2 Slope (%)	N/A
	X Walk 1 X Slope (%)	0.0		X Walk 2 X Slope (%)	N/A

Remove & Replace Entire Ramp.

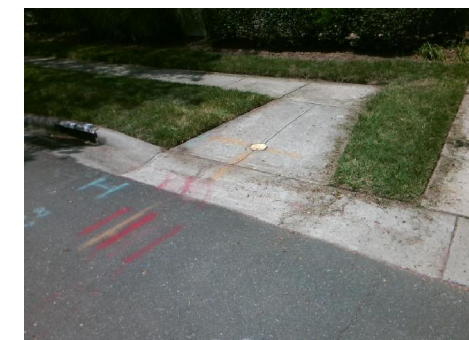
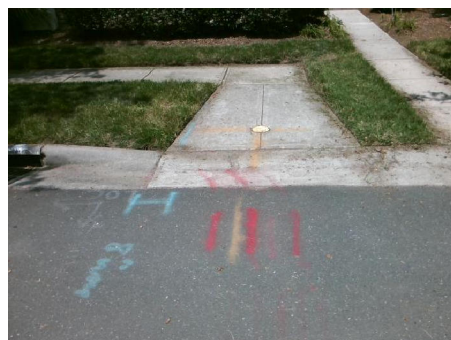
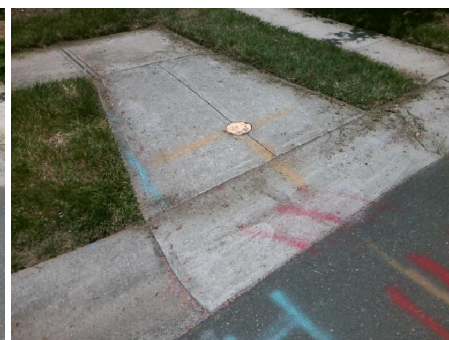
N/A	Ramp inside XWalk1?	N/A	N/A	Ramp inside XWalk2?	N/A
	Road Slope (%)	N/A	N/A	Clear Space?	N/A
	Road X Slope (%)	N/A	N/A	Clear Space to XWalk (in)	N/A
N/A	Any Obstructions?	N/A	N/A	Storm Grate/Utility Hazard?	N/A
	Obstruction Type			Storm Grate/Utility Type	
		N/A			N/A
			Yes	Surface Condition? (G/P)	Good
