# Access Compliance Report

## Public Rights-of-Way

### (Curb Ramps)

Intersection ID: 9188	Main Street: BANCROFT_ST	Cross Street: NORRIS_AV	Location:	N
ADA ID: D0F6ECC5AD36	Ramp Type: PerpDiag	Initial Pass/Fail: Fail	Overall Compliance: No	Severity Score: 8.75

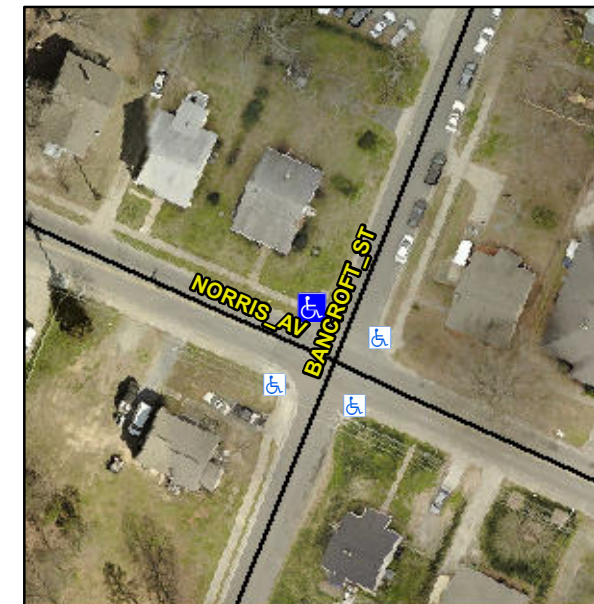
Compliance	Description	Data	Compliance	Description	Data
N/A	Ramp Length (in)	49.0	Yes	Ramp Slope (%)	7.5
No	Ramp Width (in)	47.5	Yes	Ramp XSlope (%)	0.8
N/A	Flare Type LT	N/A	N/A	Flare Type RT	N/A
N/A	Flare Slope LT (%)	N/A	N/A	Flare Slope RT (%)	N/A
N/A	Flare Traversable LT?	N/A	N/A	Flare Traversable RT?	N/A
N/A	Landing Length (in)	N/A	N/A	DWS Provided?	N/A
N/A	Landing Width (in)	N/A	N/A	DWS Contrast?	N/A
N/A	Landing Slope (%)	N/A	N/A	DWS Length (in)	N/A
N/A	Landing X Slope (%)	N/A	N/A	DWS Full Width?	N/A
N/A	Landing Curb? (Y/N)	N/A	N/A	DWS Offset (in)	N/A
N/A	Shared Landing?	N/A			
N/A	Gutter Ponding?	N/A	N/A	Gutter Slope (%)	N/A
N/A	Gutter Lip Ht (in)	0.5	N/A	Gutter X Slope (%)	N/A
N/A	Painted X Walk1?	No	N/A	Painted X Walk2?	No
	X Walk 1 Direction	To SW		X Walk 2 Direction	To SE
N/A	X Walk 1 Width (in)	N/A	N/A	X Walk 2 Width (in)	N/A
	X Walk 1 Slope (%)	0.9		X Walk 2 Slope (%)	2.1
	X Walk 1 X Slope (%)	2.0		X Walk 2 X Slope (%)	0.2

N/A	Ramp inside XWalk1?	N/A	N/A	Ramp inside XWalk2?	N/A
	Road Slope (%)	0.9	N/A	Clear Space?	N/A
	Road X Slope (%)	1.7	N/A	Clear Space to XWalk (in)	N/A
N/A	Any Obstructions?	N/A	N/A	Storm Grate/Utility Hazard?	N/A
	Obstruction Type			Storm Grate/Utility Type	
		N/A			N/A
			Yes	Surface Condition? (G/P)	Good

**Remove & Replace Curb Ramp With Two New Directional Ramps or Equivalent.**

**R304.5.1**

**\$ 3200.00**
