Access Compliance Report Public Rights-of-Way (Curb Ramps)

Intersection ID: N/A Main Street: STEELE_CREEK_RD Cross Street: N/A Location: SE **Overall Compliance: No Severity Score:** ADA ID: D105573A80B9 Ramp Type: Perp Initial Pass/Fail: Fail 12.5

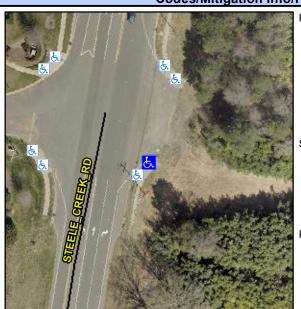
I/A	Ramp Length (in)	60.0	No	Ramp Slope (%)	10.4
'es	Ramp Width (in)	60.0	Yes	Ramp XSlope (%)	0.0
l/A	Flare Type LT	N/A	N/A	Flare Type RT	N/A
I/A	Flare Slope LT (%)	N/A	N/A	Flare Slope RT (%)	N/A
I/A	Flare Traversable LT?	N/A	N/A	Flare Traversable RT?	N/A
I/A	Landing Length (in)	N/A	N/A	DWS Provided?	N/A
I/A	Landing Width (in)	N/A	N/A	DWS Contrast?	N/A
I/A	Landing Slope (%)	N/A	N/A	DWS Length (in)	N/A
I/A	Landing X Slope (%)	N/A	N/A	DWS Full Width?	N/A
I/A	Landing Curb? (Y/N)	N/A	N/A	DWS Offset (in)	N/A
I/A	Shared Landing?	N/A			
I/A	Gutter Ponding?	N/A	N/A	Gutter Slope (%)	N/A
l/A	Gutter Lip Ht (in)	N/A	N/A	Gutter X Slope (%)	N/A
I/A	Painted X Walk1?	No	N/A	Painted X Walk2?	N/A
	X Walk 1 Direction	To N		X Walk 2 Direction	N/A
I/A	X Walk 1 Width (in)	N/A	N/A	X Walk 2 Width (in)	N/A
	X Walk 1 Slope (%)	0.7		X Walk 2 Slope (%)	N/A
	X Walk 1 X Slope (%)	0.5		X Walk 2 X Slope (%)	N/A
I/A	Ramp inside XWalk1?	N/A	N/A	Ramp inside XWalk2?	N/A

Possible Solutions:	Compli	ance	Description
Remove & Replace Entire Ramp.	N/A	Ram	Length (in)
·	Yes	Ramp	Width (in)
	N/A	Flare	Type LT
	N/A	Flare	Slope LT (%)
	N/A	Flare	Traversable LT
	N/A	Land	ng Length (in)
Surveyor Notes:	N/A	Land	ng Width (in)
N/A	N/A	Land	ng Slope (%)
	N/A	Land	ng X Slope (%)
	N/A	Land	ing Curb? (Y/N)
	N/A	Share	ed Landing?
PROW/ADA:	N/A	Gutte	er Ponding?
Not Found, R304.2.2	N/A	Gutte	er Lip Ht (in)
	N/A	Paint	ed X Walk1?
		X Wa	lk 1 Direction
	N/A	X Wa	lk 1 Width (in)
		X Wa	lk 1 Slope (%)
		X Wa	lk 1 X Slope (%
	N/A	Ram	inside XWalk1

N/A
		N/A
		N/A
		N/A
Total Cost:	\$ 1850.00
