# Access Compliance Report

## Public Rights-of-Way

### (Curb Ramps)

Intersection ID: 10154	Main Street: SLOAN_DR	Cross Street: TUCKASEEGEE_RD	Location: E
ADA ID: D1055FAC58E1	Ramp Type: Combination1	Initial Pass/Fail: Fail	Overall Compliance: No
			Severity Score: 33.75

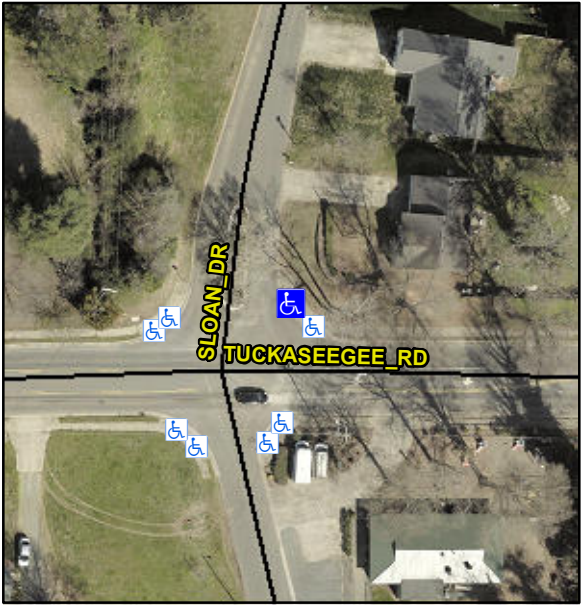
Possible Solutions:		<b>Compliance</b>	<b>Description</b>	<b>Data</b>
	<b>Remove &amp; Replace Entire Ramp.</b>		<b>Compliance</b>	<b>Description</b>	<b>Data</b>
<p>Surveyor Notes:</p> <p><b>LT RP &lt; 5%</b></p> <p>PROW/ADA:</p> <p><b>Not Found, R304.5.1, R304.2.2, R304.5.3, R304.3.2</b></p>			N/A	Ramp Length LT (in)	61.0
			Yes	Ramp Width LT (in)	82.0
<p>Street 1 Name</p> <p>Stop Condition-Street 1</p> <p>Street 2 Name</p> <p>Stop Condition-Street 2</p>			Yes	Ramp Slope LT (%)	4.0
			No	Ramp XSlope LT (%)	4.8
<p>Total Cost:</p> <p>\$ 1800.00</p>			N/A	Ramp Length (in)	82.0
			No	Ramp Width (in)	41.5
			N/A	Flare Type LT	N/A
			N/A	Flare Slope LT (%)	N/A
			N/A	Flare Traversable LT?	N/A
			N/A	Landing Length (in)	N/A
			N/A	Landing Width (in)	N/A
			N/A	Landing Slope (%)	N/A
			N/A	Landing X Slope (%)	N/A
			N/A	Landing Curb? (Y/N)	N/A

N/A	Shared Landing?	N/A
			N/A	Gutter Ponding?	N/A
			N/A	Gutter Lip Ht (in)	N/A
			N/A	Painted X Walk1?	No
				X Walk 1 Direction	To W
				X Walk 1 Width (in)	N/A
				X Walk 1 Slope (%)	0.8
				X Walk 1 X Slope (%)	5.4
			N/A	Ramp inside XWalk1?	N/A
			N/A	Road Slope (%)	N/A
			N/A	Road X Slope (%)	N/A
			N/A	Clear Space?	N/A
			N/A	Clear Space to XWalk (in)	N/A
			N/A	Any Obstruction?	N/A
				Obstruction Type	N/A
					N/A
			N/A	Storm Grate/Utility Hazard?	N/A
				Storm Grate/Utility Type	N/A
					N/A
			Yes	Surface Condition? (G/P)	Good
				Curb Slope (%)	14.1
