Access Compliance Report Public Rights-of-Way (Curb Ramps)

Intersection ID: 49926Main Street:CAMPBELL_HALL_CTCross Street: WOBURN_RDLocation:SWADA ID: D10D60C05525Ramp Type:PerpInitial Pass/Fail:FailOverall Compliance: NoSeverity Score:22.5

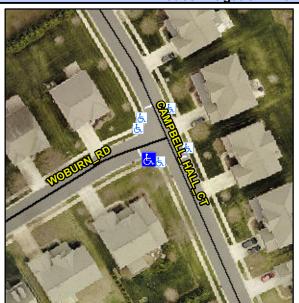
Comp	liance Description	Data			Description	Data
N/A	Ramp Length (in)	48.0	No	Ram	Slope (%)	9.0
No	Ramp Width (in)	46.0	No	Ram	XSlope (%)	3.1
N/A	Flare Type LT	N/A	N/A	Flare	Type RT	N/A
N/A	Flare Slope LT (%)	N/A	N/A	Flare	Slope RT (%)	N/A
N/A	Flare Traversable LT?	N/A	N/A	Flare	Traversable RT?	N/A
N/A	Landing Length (in)	N/A	N/A	DWS	Provided?	N/A
N/A	Landing Width (in)	N/A	N/A	DWS	Contrast?	N/A
N/A	Landing Slope (%)	N/A	N/A	DWS	Length (in)	N/A
N/A	Landing X Slope (%)	N/A	N/A	DWS	Full Width?	N/A
N/A	Landing Curb? (Y/N)	N/A	N/A	DWS	Offset (in)	N/A
N/A	Shared Landing?	N/A				
N/A	Gutter Ponding?	N/A	N/A	Gutte	er Slope (%)	N/A
N/A	Gutter Lip Ht (in)	N/A	N/A	Gutte	er X Slope (%)	N/A
N/A	Painted X Walk1?	No	N/A	Paint	ed X Walk2?	N/A
	X Walk 1 Direction	To NW		X Wa	lk 2 Direction	N/A
N/A	X Walk 1 Width (in)	N/A	N/A	X Wa	lk 2 Width (in)	N/A
	X Walk 1 Slope (%)	4.1		X Wa	lk 2 Slope (%)	N/A
	X Walk 1 X Slope (%)	2.4		X Wa	lk 2 X Slope (%)	N/A

N/A	Ramp inside XWalk1?	N/A	N/A	Ram	o inside XWalk2?	N/A
	Road Slope (%)	N/A	N/A	Clear	Space?	N/A
	Road X Slope (%)	N/A	N/A	Clear	Space to XWalk (in)	N/A
N/A	Any Obstructions?	N/A	N/A	Storn	n Grate/Utility Hazard?	N/A
	Obstruction Type			Storn	n Grate/Utility Type	
		N/A				N/A
			Yes	Surfa	ce Condition? (G/P)	Good

Possible Solutions:	<u>c</u>	
Remove & Replace Entire Ramp.		
•	N	
	N	
	N	
	N	
	N	
Surveyor Notes:	N	
N/A	N	
	N	
	N	
	N	
PROW/ADA:	N	
Not Found, R304.5.1, R304.2.2,	N	
R304.5.3	N	
	N

otal Cost:	\$	1850.00
	151	מולוו
