Access Compliance Report

Public Rights-of-Way (Curb Ramps)

Intersection ID: 23730	Main Street: PROVIDENCE_RD	Cross Street: CEDAR_CROFT_DR	Location: SE
ADA ID: D10DE8AA27FE	Ramp Type: Perp	Initial Pass/Fail: Fail	Overall Compliance: No
Codes/Mitigation Info/Possible Solution		Field Measurements/Component Compliance	
Severity Score: 21.25

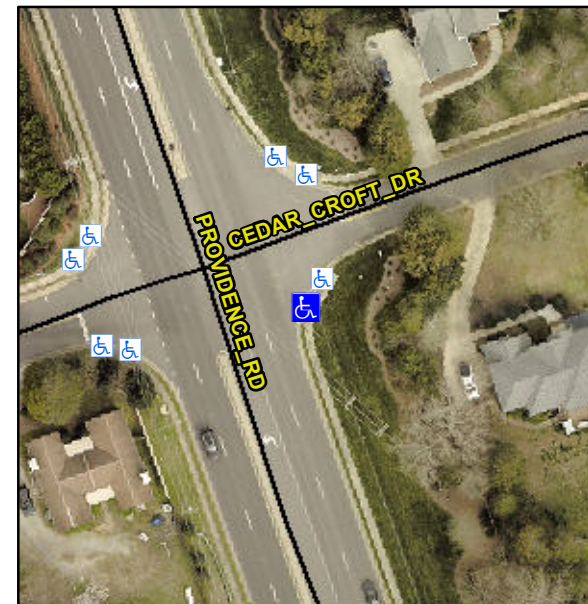
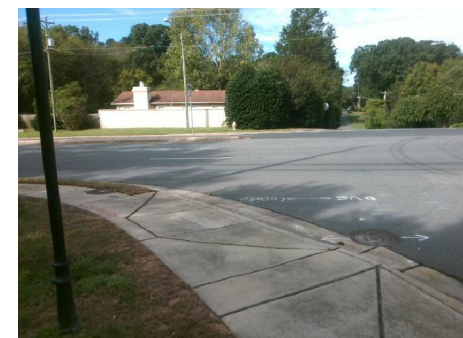
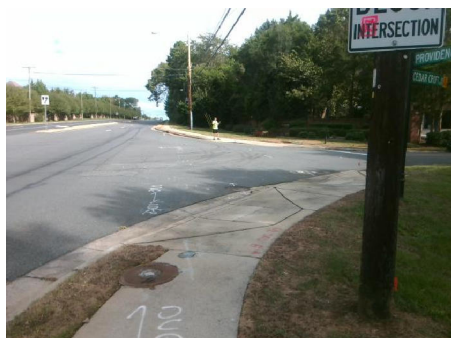
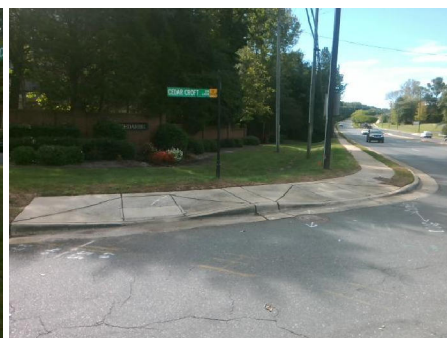
R304.5.1, R304.2.2

Compliance	Description	Data	Compliance	Description	Data
N/A	Ramp Length (in)	61.0	No	Ramp Slope (%)	9.5
No	Ramp Width (in)	47.5	Yes	Ramp XSlope (%)	1.6
N/A	Flare Type LT	N/A	N/A	Flare Type RT	N/A
N/A	Flare Slope LT (%)	N/A	N/A	Flare Slope RT (%)	N/A
N/A	Flare Traversable LT?	N/A	N/A	Flare Traversable RT?	N/A
N/A	Landing Length (in)	N/A	N/A	DWS Provided?	N/A
N/A	Landing Width (in)	N/A	N/A	DWS Contrast?	N/A
N/A	Landing Slope (%)	N/A	N/A	DWS Length (in)	N/A
N/A	Landing X Slope (%)	N/A	N/A	DWS Full Width?	N/A
N/A	Landing Curb? (Y/N)	N/A	N/A	DWS Offset (in)	N/A
N/A	Shared Landing?	N/A			
N/A	Gutter Ponding?	N/A	N/A	Gutter Slope (%)	N/A
N/A	Gutter Lip Ht (in)	N/A	N/A	Gutter X Slope (%)	N/A
N/A	Painted X Walk1?	No	N/A	Painted X Walk2?	N/A
	X Walk 1 Direction	To W		X Walk 2 Direction	N/A
N/A	X Walk 1 Width (in)	N/A	N/A	X Walk 2 Width (in)	N/A
	X Walk 1 Slope (%)	4.5		X Walk 2 Slope (%)	N/A
	X Walk 1 X Slope (%)	3.7		X Walk 2 X Slope (%)	N/A

N/A	Ramp inside XWalk1?	N/A	N/A	Ramp inside XWalk2?	N/A
	Road Slope (%)	N/A	N/A	Clear Space?	N/A
	Road X Slope (%)	N/A	N/A	Clear Space to XWalk (in)	N/A
N/A	Any Obstructions?	N/A	N/A	Storm Grate/Utility Hazard?	N/A
	Obstruction Type			Storm Grate/Utility Type	
		N/A			N/A
			Yes	Surface Condition? (G/P)	Good

Remove & Replace Entire Ramp.

Total Cost: \$ 1850.00
